On materials science aspects of impact of cannon ball on the stability of the Delhi Iron Pillar

R. Balasubramaniam

Department of Materials and Metallurgical Engineering, Indian Institute of Technology, Kanpur 208 016, India

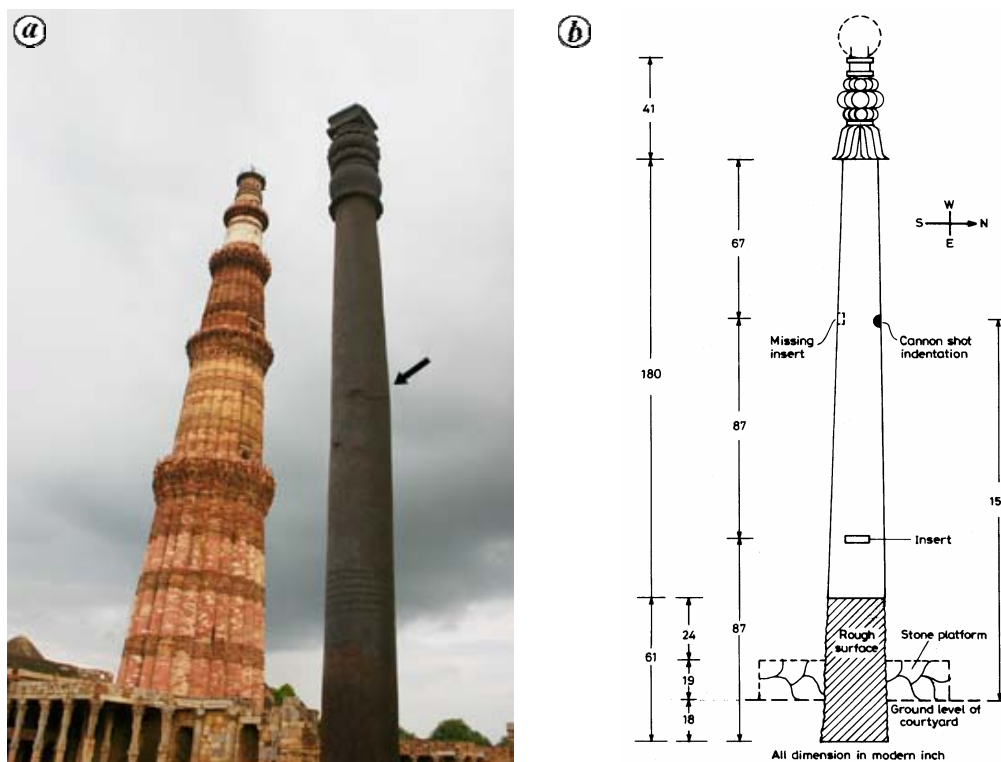
One of the significant marks on the pillar is the indentation of a cannon ball that struck the pillar for a brief moment ($<10^{-6}$ s) in its history (Figure 1*a*). The indentation

is located at 156 in from the current courtyard ground level (Figure 1*b*). The diameter of the cannon ball has been estimated to be 5 inches based on plaster of Paris cast of indentation area⁹.

Figure 1. *a*, Delhi Iron Pillar located at the Quwwat-ul-Islam mosque in the Qutub Complex, New Delhi. Arrow shows the cannon ball strike location on the pillar. *b*, Salient dimensions of the pillar showing the relative position of the cannon ball indentation and the inserts. The overall symmetric design of the pillar must be appreciated.

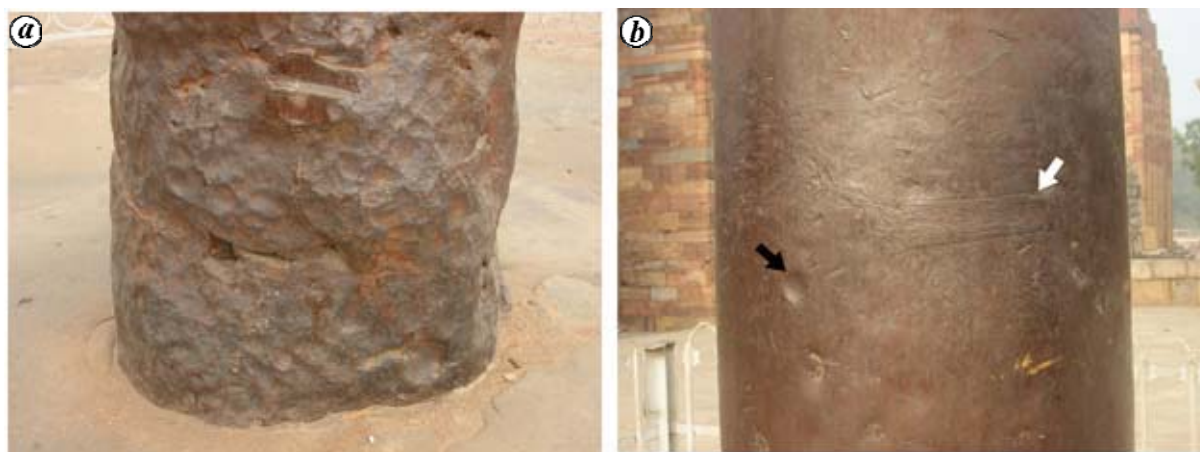
Further, Prasad and Ray¹² noted several smaller diameter indentation marks and concluded that these indicated that sledgehammers were first used to topple the pillar and thereafter the cannon shot was fired. The sledgehammer marks (Figure 3*a*) belong to a time when the pillar was originally forge-welded from individual lumps (of approximate weight 20–30 kg) by horizontal forge-welding method, with the metal lumps added to the main body in a sideways fashion⁶. Some smaller indentation marks located about waist level (black arrowed location, Figure 3*b*) are craters due to shots fired from small arms, and not due to cannon fire.

Figure 3. *a*, Sledgehammer marks on the bottom portion of the pillar due to the original manufacturing technology. *b*, Indentation mark (black arrow) caused by a shot from the fire arm. The outlines of a rectangular insert can be noted at the location indicated by the white arrow.

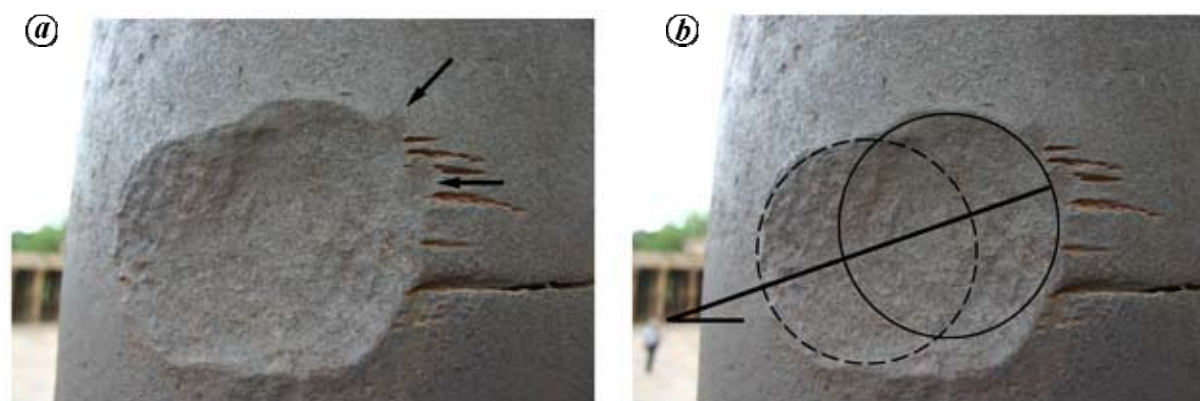
Figure 4. Close-up view of the cannon ball indentation location. *a*, Two shear lips around the cannon ball crater (arrows). *b*, Analysis of the indentation area showing the location where the cannon ball first made an impact (dotted circle) and location where the cannon ball came to a halt (full circle). The trajectory of the ball is indicated by the slanted line.

made. First, the complete impression of the cannon shot is not perfectly circular and the depression is skewed. The depth at the right side (Figure 4 *a*) of the indentation is more than that at the left side (Figure 4 *a*). The left side of the indentation, due to its lower depth⁹, indicates grazing of the ball on its way to the impact. The exact location of the final impact is on the right side of the indentation.

The direction of the cannon shot is deduced to be from the northern direction (Figure 2). The cannon ball first made contact on the left side of the indentation area (dotted circle, Figure 4 *b*) and then came to rest on the right side (full circle, Figure 4 *b*). The trajectory of the cannon ball can also be understood by noting the relative position of the centres of these two circles (slanting line, Figure 4 *b*). The trajectory points from the bottom to the top, thereby confirming that the cannon shot landed on the pillar on its upward motion from the cannon. Another important conclusion is that the angle of the trajectory is 15° , as determined using the slanting and the horizontal lines in Figure 4 *b*.

The plastic strains generated due to the initial grazing motion of the ball and the final impact can also be clearly distinguished on the indentation area (Figure 4 *a*). The surface features on the left of the cannon ball indentation area reveal material removal due to grazing motion of the high-velocity projectile. The features on the right reveal higher degree of deformation caused by the final impact. That the final impact was on the right side of the indentation is further corroborated by an important material evidence, namely the creation of shear lips just at the right of the cannon ball strike location. This is indicated in Figure 4 *a*, where two shear lips are shown (arrows).

The origin of the shear lip is due to material erosion effects at the high velocity projectile impact. When a dense material (like lead cannon ball) impacts the surface with force, it is shattered due to the impact force and the shattered small pieces cause further deformation at the edges of the main impact location¹⁷. The appearance of these shear lips confirms the fracture of the cannon ball into

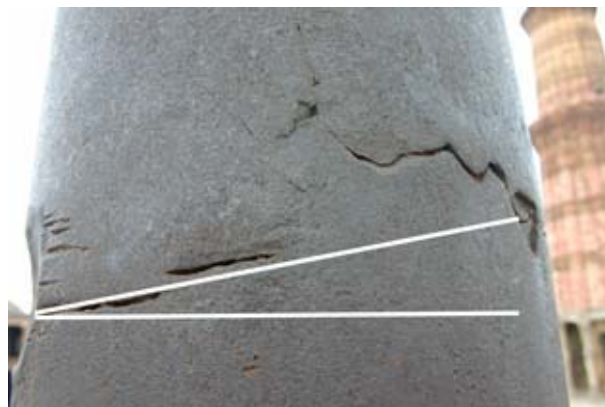
The local fracture adjoining the impact location (to the right of the cannon ball crater) is aligned along a certain direction (Figure 6). Its origin is due to the interaction of the travelling plastic compressive stress shock wave with

the free surface. Its arrest resulted due to the velocity of the moving plastic wave being higher than the crack velocity. Shock waves propagate in solids at the rate of 1–6 km/s, while the velocity of crack propagation¹⁸ is of the order of 2 km/s. Therefore, with impulsive loading, it is generally noticed that cracks form but do not have time to propagate before the stress state changes. This explains the cracking seen on the right side of the cannon ball mark on the pillar (Figure 6).

It is also possible to estimate the trajectory of the cannon ball by relating the crack direction to the direction of the travelling shock wave. Since the cracks adjoining the indentation area are related to the direction of propagation of the wave, it is reasonable to conclude that the trajectory is given by the alignment of the cracks with respect to the horizontal. This has been marked by a slanted line in Figure 6. The angle it makes with the horizontal is 15°. The estimated trajectory matches well with that estimated from features of indentation area (Figure 4 *b*).

Figure 6. Cracks on the right side of the cannon shot indentation area are aligned in the direction of propagation of the shock wave generated due to the impact (slanted line).

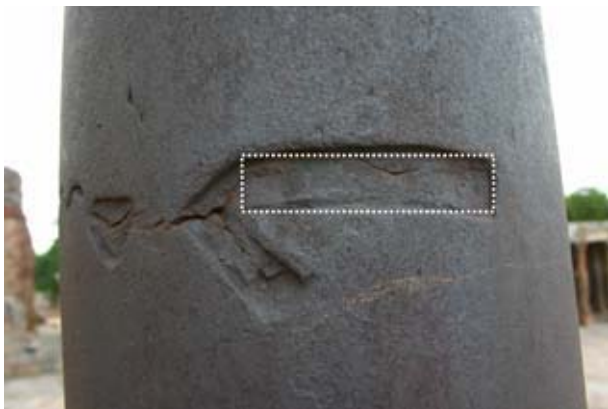
Once the travelling shock wave reached the free surface, it resulted in cracking (Figure 7). In the rear location, one

can see a triangular piece of metal and an almost rectangular lump of metal that fractured and spalled out of the surface (Figure 7). The outline of the missing rectangular material, delineating a missing insert, has been highlighted by dotted lines in Figure 7.

Figure 7. View of the cracked region on the rear, diametrically opposite to the cannon ball strike location. The outline of a previously present horizontal insert is highlighted with dotted line. Note that the material to the left side of the insert was removed by ductile shearing.

The rectangular shape of the spalled insert can be confirmed by well-delineated straight lines on top and right of the region (Figure 7). However, the shape at the left bottom region is not perfectly rectangular and additional material appears to have been sheared with the insert. This can be concluded based on fracture features (plastic tearing) observed on the bottom left portion of the area (see Figure 7 and right side of Figure 8 for higher magnification view). Therefore, it is reasonable to conclude that when the remnant of the clamp was dislodged from the surface, it had fractured some of the material of the surface by plastic tearing.

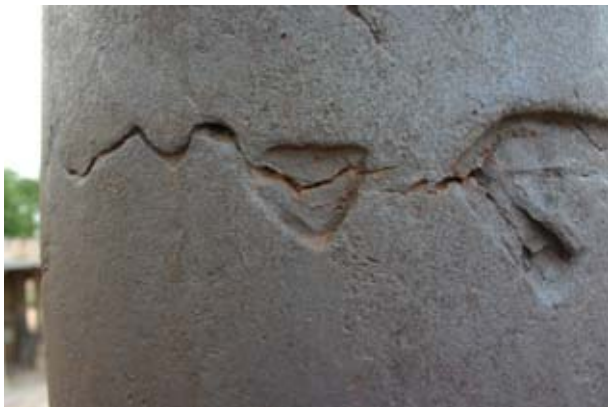
The triangular piece appears to have been a patchwork used to even out the surface. Careful observation revealed that the smooth surface of the pillar was produced by filling all cavities on the surface with smaller bits of iron and later the entire surface was chiseled, burnished and polished⁶. It is confirmed that the triangular piece was a patchwork by noting that the cracking had not progressed from the edges of the triangle. Rather, cracking is evident below the spalled triangular region (Figure 8).

Figure 8. Close-up view of the triangular-shaped spalled region on the rear side.

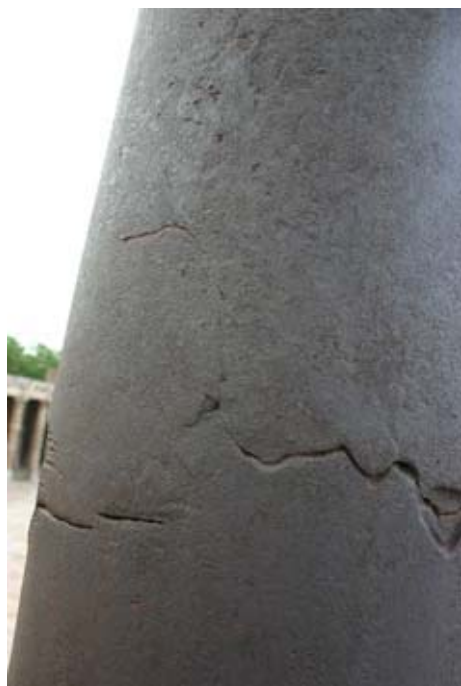
Observation of the cracking pattern noted on the side (Figures 6 and 7) and back side of indentation mark area indicates that the propagating horizontal crack from the rear side has opened out some of the lump-lump interfaces (Figure 9). The nature of cracks (i.e. close relationship between the horizontal crack and the deflected cracks delineating lump-lump interfaces) confirms that lump-lump separation is not due to the onward travelling compressive shock wave, but due to the deflection of the horizontal crack propagating from the rear of the pillar surface.

It further appears that the separation of lump-lump interfaces is also realized within the body of the pillar at this location (Figure 9). In non-destructive studies conducted on the pillar²⁷, evidences for the presence of curved, hollow spaces were obtained near the cannon ball strike location by gamma radiography. The thickness of these hollow spaces is very small. These elongated, curved,

Figure 9. Side view of the pillar at the cannon ball strike location showing deflection of the horizontal crack from the rear (right side of the image) to the axial direction of the pillar by cracking of lump–lump interface.

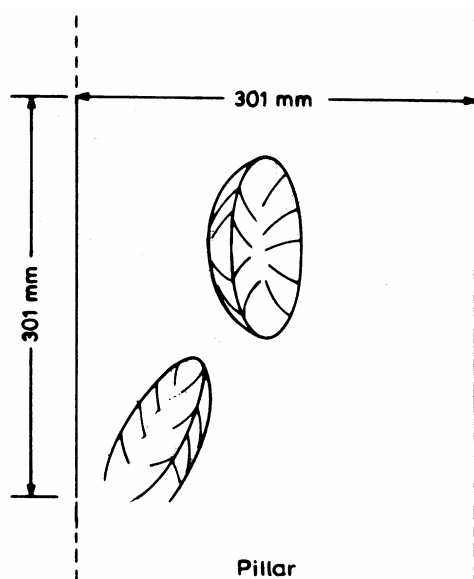
hollow spaces are shown schematically in Figure 10. The imaging of the region around the cannon ball mark by gamma radiography provides valuable proof of fabrication of the main body (using iron lumps forge-welded on the horizontal pillar in a sideways manner). It also offers

Figure 10. Schematic of elongated, curved, hollow spaces in the main body of the pillar near the location of the cannon ball strike. This has been recreated using the gamma radiographs presented in figure 3 of Raj *et al.*²⁷.

convincing proof of deflection of the propagating horizontal crack along lump–lump interfaces.
