# Isoseismals for the Kutch earthquake of 26th January 2001

A SINVHAL<sup>1</sup>, P R BOSE<sup>2</sup>, V PRAKASH<sup>1</sup>, A BOSE<sup>3</sup>, A K SARAF<sup>4</sup> and H SINVHAL<sup>4</sup>

Damage observed during the Kutch earthquake of 26th January 2001 is classified according to the type of structure. This damage pattern has been used to draw the isoseismal map on the basis of the intensity scale given in IS 1893–2002 which covers only traditional one to two storey houses. Having thus estimated intensities, and observed damage to other types of structures, a new criterion was adopted which is included in this paper. Areas that showed maximum damage to structures have been assigned maximum intensity X.

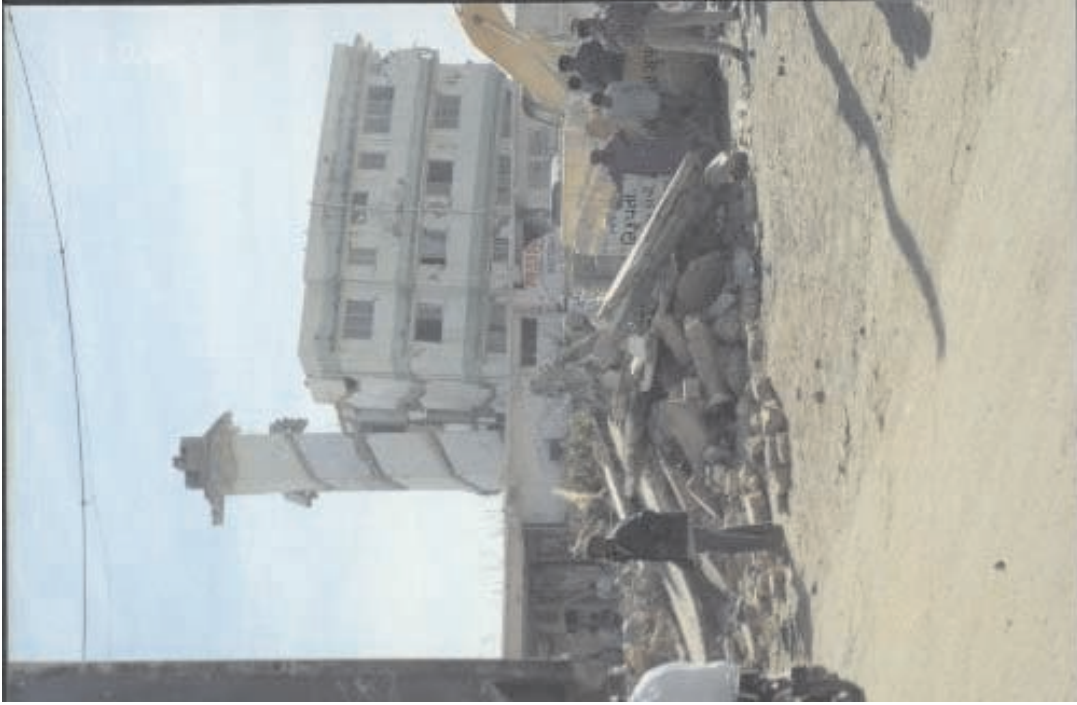
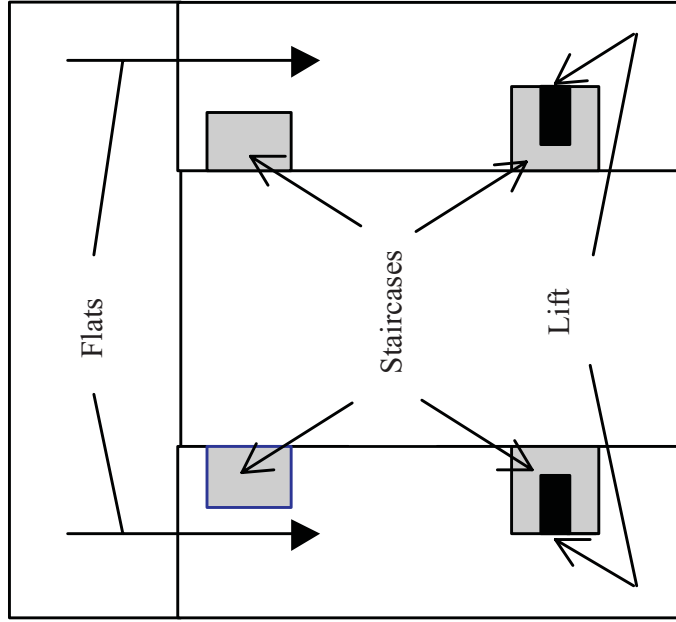
Typical Floor Plan

Figures 2 and 3. Sahil Apartments at Gandhidham and floor plan. People connected with the salt trade lived in these 300 modest apartments of 2 bedrooms, a hall, a kitchen and toilets. In this 5 storeyed building the ground floor was a soft storey and was used for parking. The middle arm of this C shaped building had shops at ground level, which extended to the upper floor in the form of a plaza.

Balconies, like in many other places, were connected to rooms. Due to the change in floor area of flats, placement of filler walls changed from third floor upwards which introduced a change in vertical stiffness.

This building had two lifts and four staircases. The staircase was raised spirally along the sides of lift well. Connection between the slab and shear core was missing. The diaphragm was not well connected to the lift core to transfer the shear. Huge water tanks were placed on top or near the staircase/lift core, in all wings.

Three storeys of a small portion of the building remained standing, seen in the photograph above, because of some partial attachment of stiff core of lift shaft to staircase. The lift shaft separated from the rest of the building. Torsion occurred due to discontinuity of horizontal and vertical configuration.

This RC framed structure suffered a damage of grade 5. This is a typical example where one should assign a low vulnerability class, in this case A (MSK-64 scale in IS 1893-2002), which represents an exceptionally low class for this type of structure. Poorly made structures in Gandhidham show similar damage and hence Gandhidham has been assigned intensity VIII.
