Behaviour of masonry structures during the Bhuj earthquake of January 2001

K S JAGADISH¹, S RAGHUNATH² and K S NANJUNDA RAO³

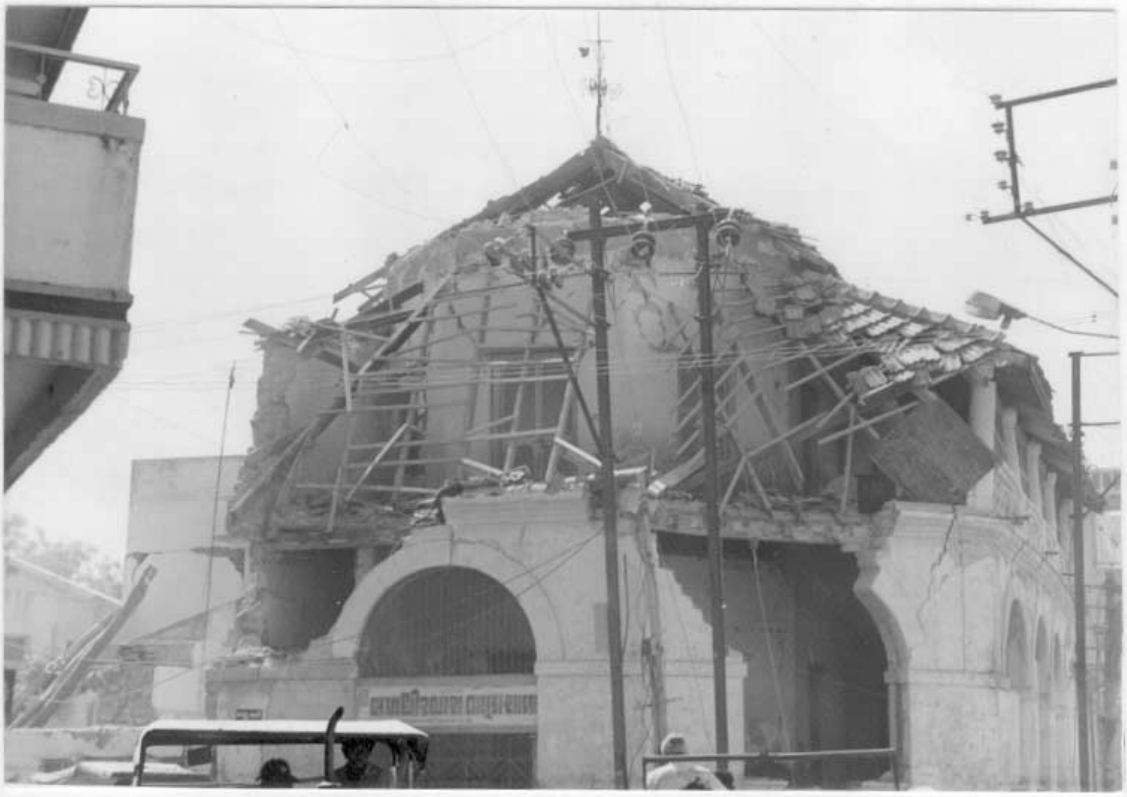
The old buildings in the town of **Morbi** were essentially made of well-cut sandstone units in lime mortar. All such buildings have responded badly whereas, neighbouring brick-in-cement-mortar buildings survived although they developed extensive cracks. The failure pattern may be essentially characterized as out-of-plane failure due to the extremely low value

Figure 1. Out-of-plane collapse (Morbi).

of flexural strength. Figure 1 shows one such typical failure. Out-of-plane failure of parapet walls, failure of stair case blocks was also quite common.

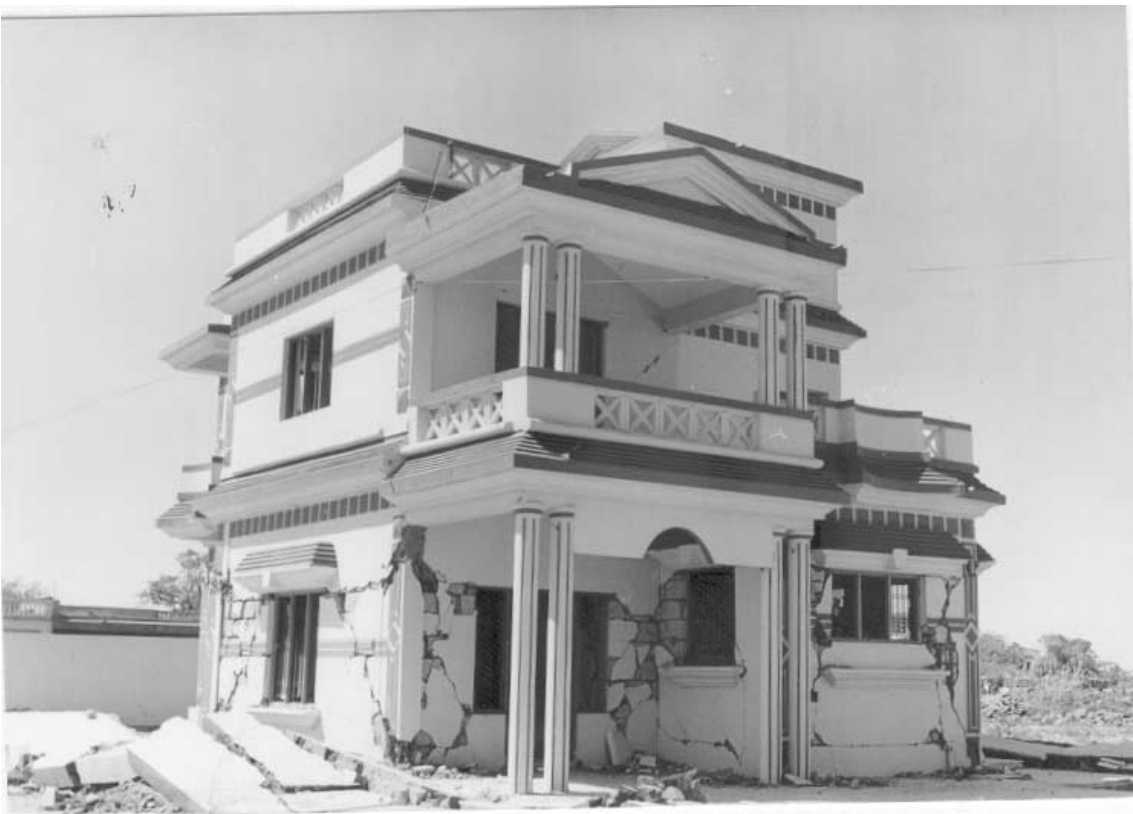
Figure 2. House with lintel band and corner columns, cracks below band (Samakhyali).

In **Samakhyali**, the behaviour of an interesting two storeyed building with earthquake resistant features could be observed (figure 2). This building was constructed using cement blocks, with continuous lintel band and corner RC columns. This building did not collapse, but had developed extensive cracks below the lintel band. The portion of the building above the lintel band was practically crack-free. The corner columns suffered severe damage. It appears as though the portion below the lintel band behaved like a 'soft first storey', absorbing all the energy. It is indeed clear that the lintel band protected the portion above by creating a rigid block. The damage below the lintel band may indicate the need for horizontal band, possibly at sill level. The provision of the RC column at the corners or elsewhere, without bonding with the infill walls is not helpful as it causes a discontinuity in masonry walls leading to the building losing its integrity (figure 3).

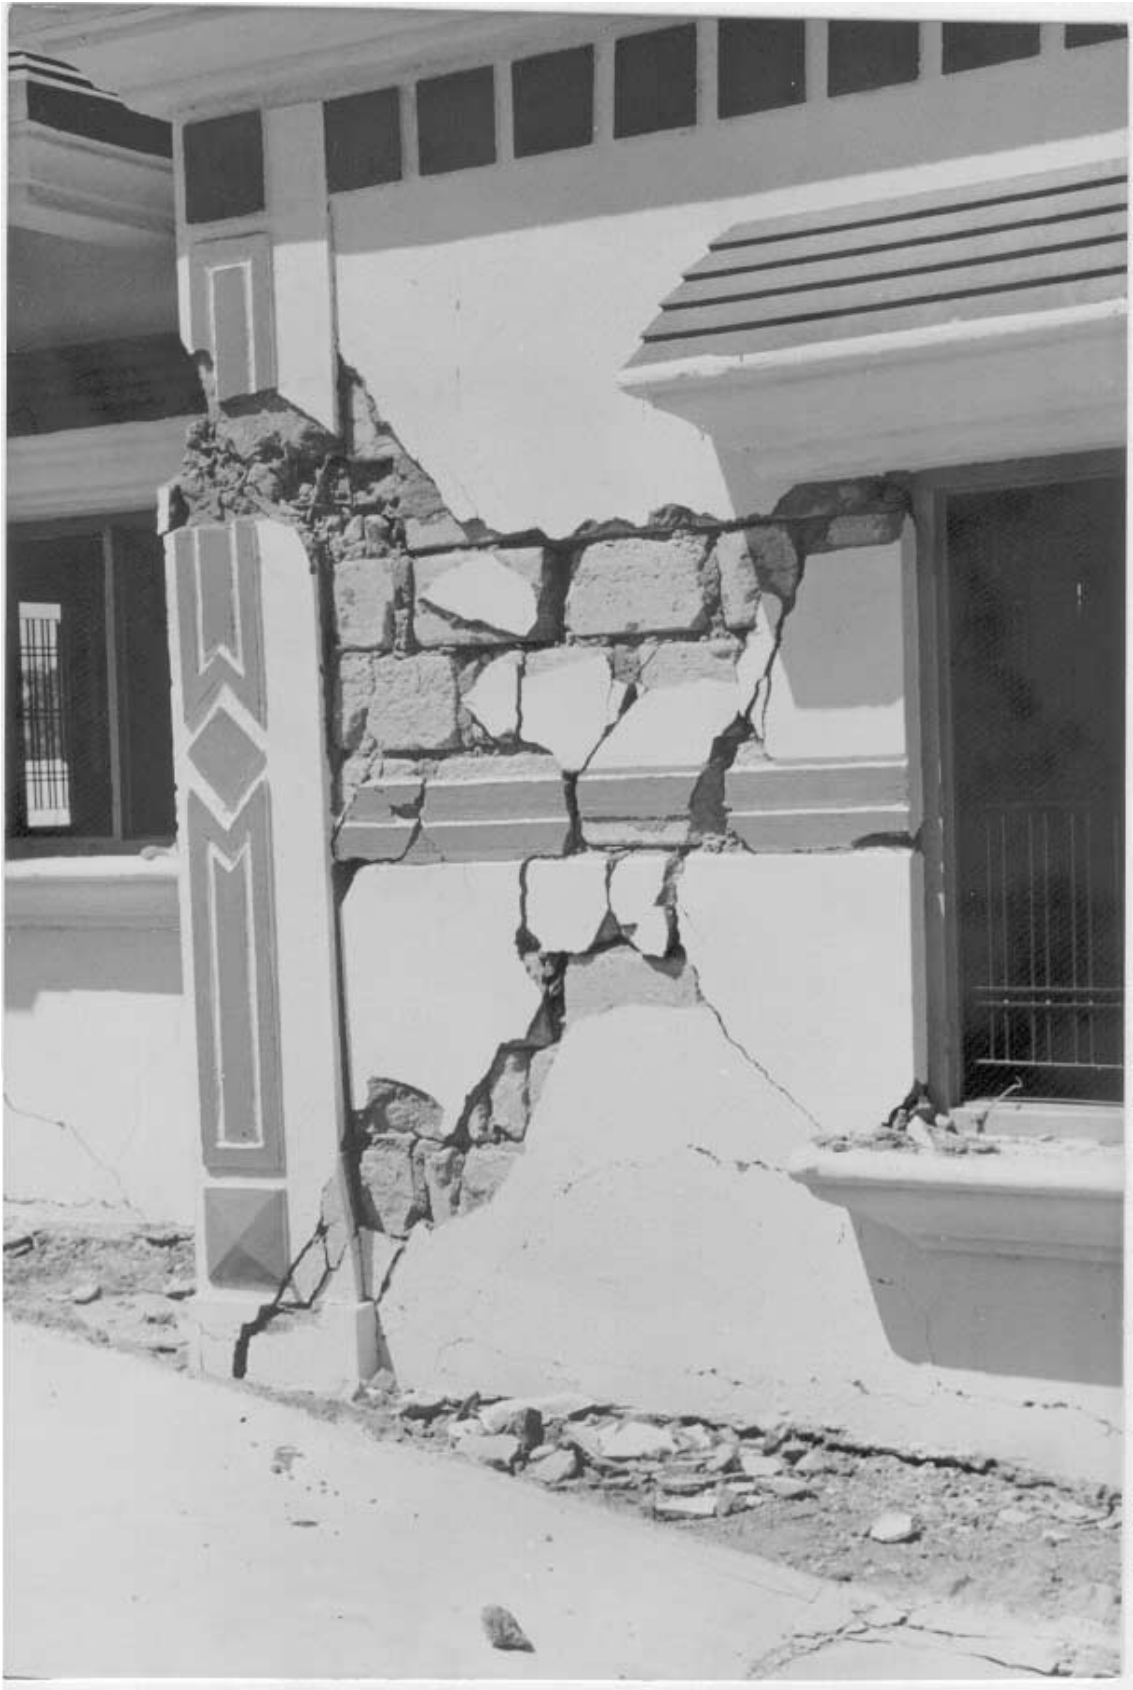
Figure 3. Wall separated from column (Samakhyali).

- Masonry with cement mortar (which has higher bond strength) has generally behaved better, although it does not mean that good masonry bonding is all that is needed for earthquake resistance.
- Use of lintel band, as suggested by the Bureau of Indian Standards (IS 13828:1993), appears to introduce a rigid box-like behaviour in the upper portions of the building while the portion below the lintel band is cracked badly (figure 11). This horizontal reinforcement in the band does not seem to improve the ductility to the desired level. This seems to suggest that additional horizontal bands, possibly at the sill level and at plinth level, are needed.
- The provision of corner reinforcement in corners and junctions, again as suggested by BIS, has to be properly bonded with the surrounding masonry possibly with dowels or keys to prevent separation.

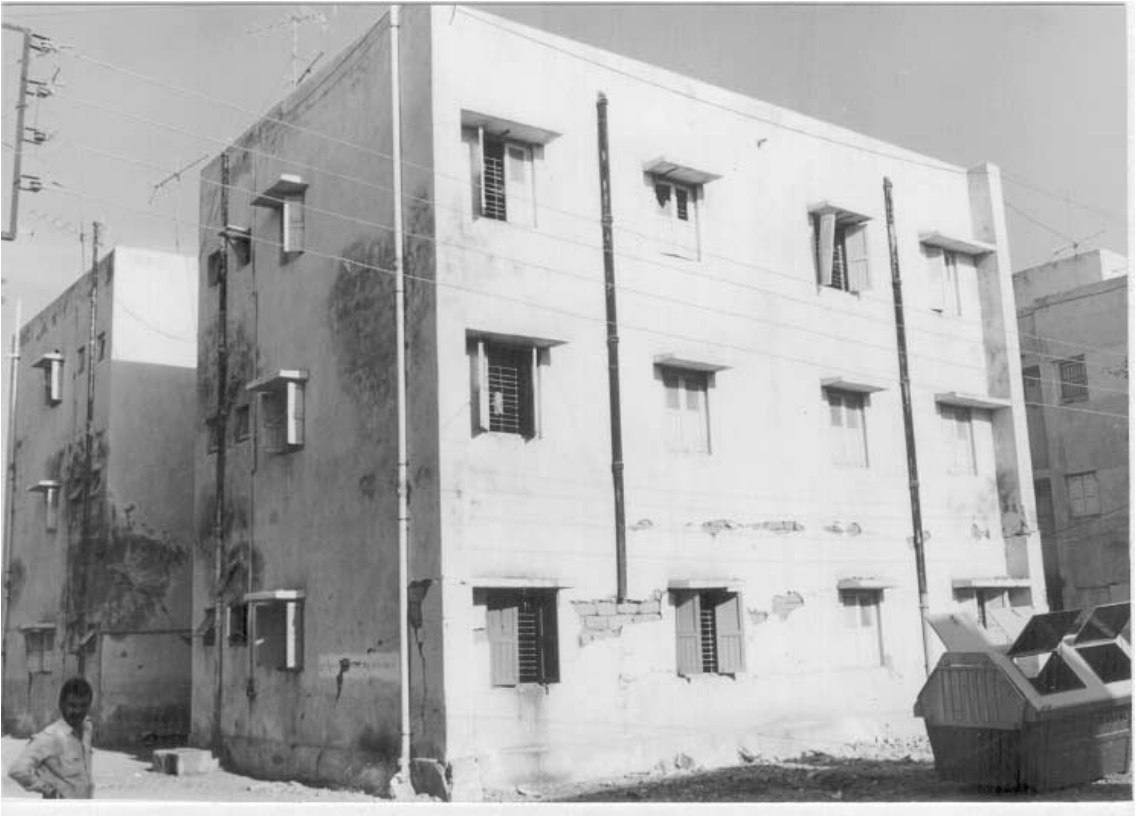
Figure 4. Stone masonry building in CM with minor damage (Bhuj).

The structures in the old town of **Bhuj**, within the fort premises, were devastated. There were many one- and two-storeyed stone-in-mud type buildings with poor bonding, of which none had survived. However, in the new Bhuj town, most of the one- or two-storeyed buildings using brick/stone in cement mortar behaved reasonably well with minor cracks. Figure 4 shows a three-storeyed stone masonry building with cement mortar, which had performed rather well, while a near-by framed RC structure, had collapsed. Some of the masonry buildings built by the CPWD had earthquake resistant features like lintel band and corner reinforcement. Two such buildings were studied. In one building the wall below the lintel band suffered out-of-plane failure and the lintel band also had come down (figure 5). In another

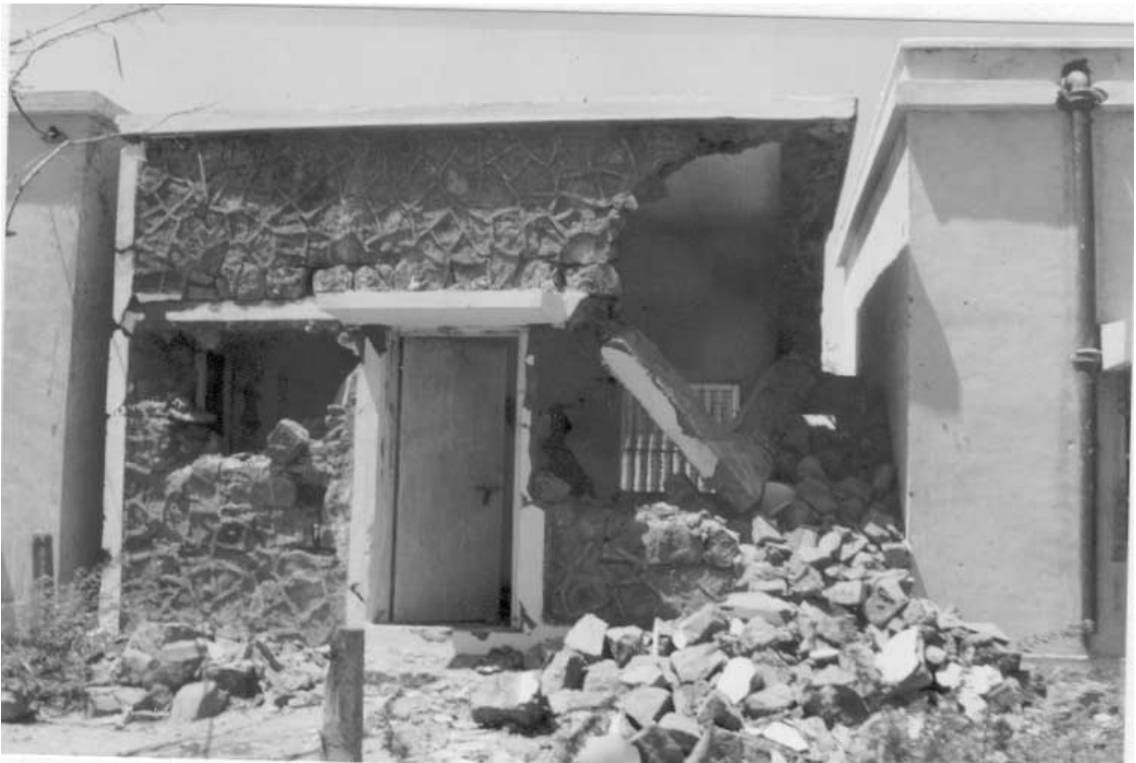
Figure 5. Out-of-plane failure of wall leading to collapse of lintel band (Bhuj).

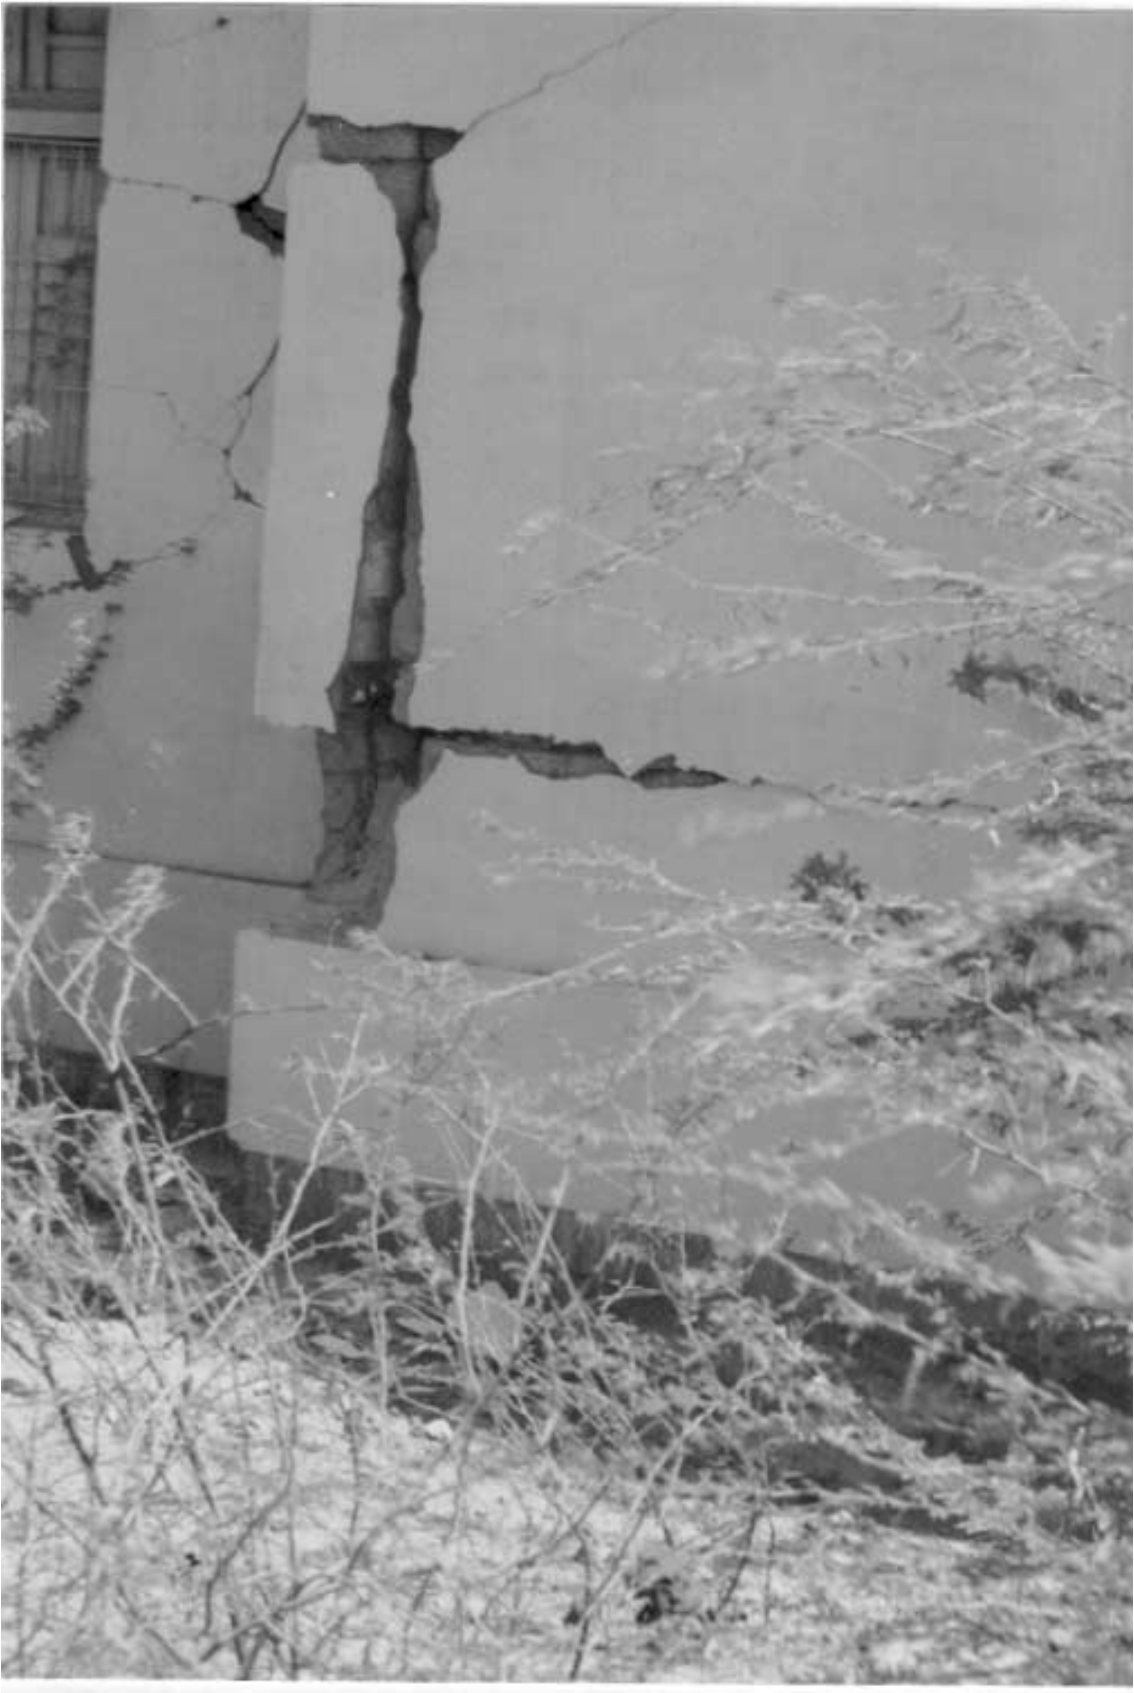
Figure 6. Corner failure in the presence of corner reinforcement (Bhuj).

building, the corners were badly fractured and the stones came out inspite of the corner reinforcement. The provision of the corner reinforcement is not possible without having a continuous

vertical joint, whereas, masonry demands that continuous vertical joints be avoided. These buildings indicate the inadequacy of such measures when the ground motion intensity is high (figure 6).

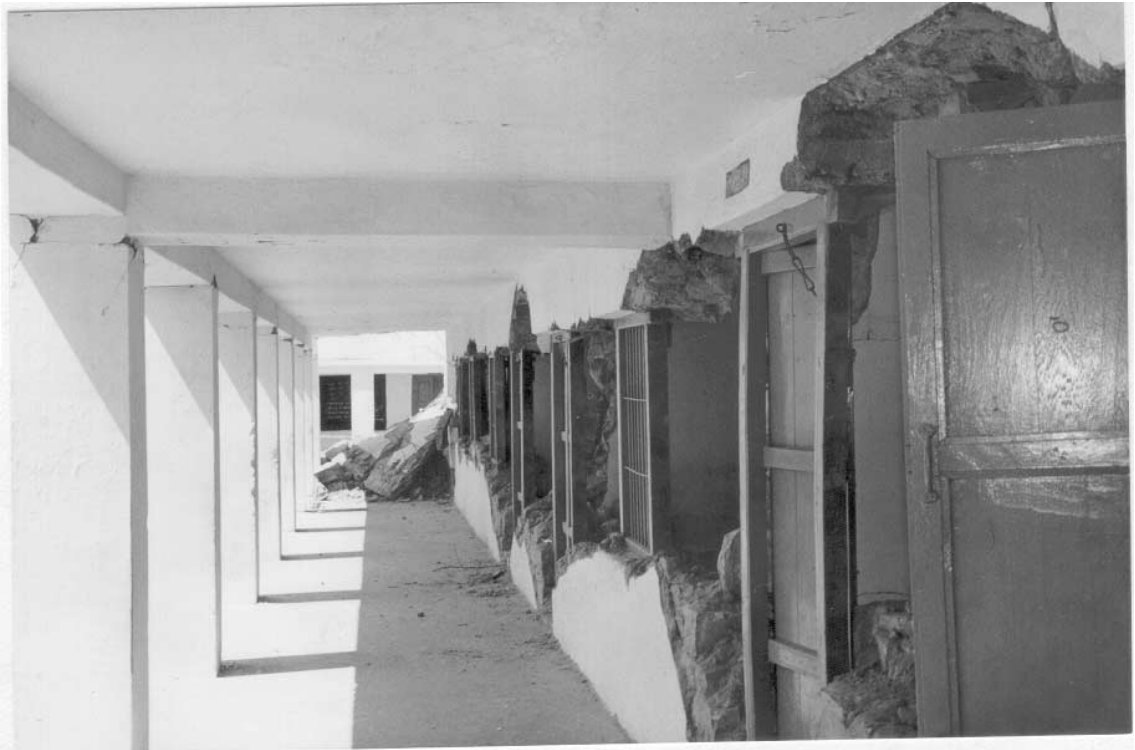
Figure 7. Collapse of wall between openings (Khavda).

Figure 7 shows a school building in **Khavda**, with typical out-of-plane failure of walls between two openings. Studies (Satish Kumar 1999) have shown that the strip of wall between two large openings experiences large deformations during flexural vibrations. A well dressed stone masonry building, for Kutch Navnirman Abhiyan, with cement mortar and light ferrocement roofing behaved well with very little cracking (figure 8).

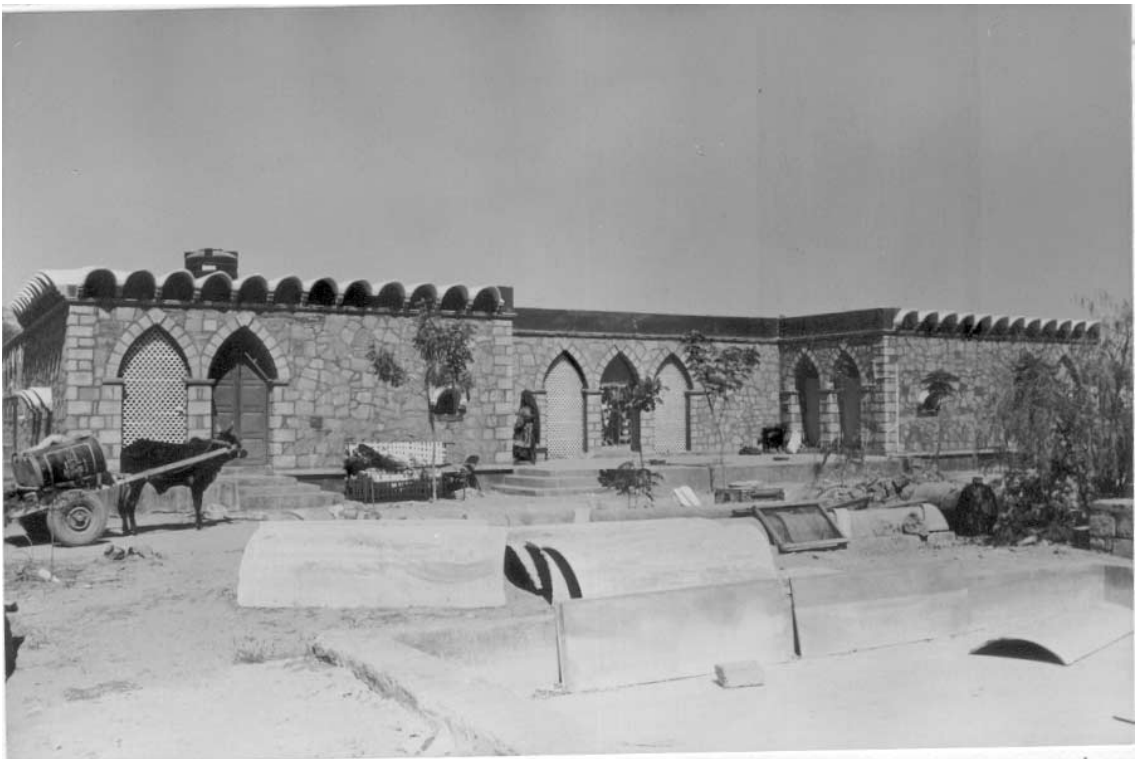
Figure 8. Well dressed stone in CM with ferrocement roof (Khavda).

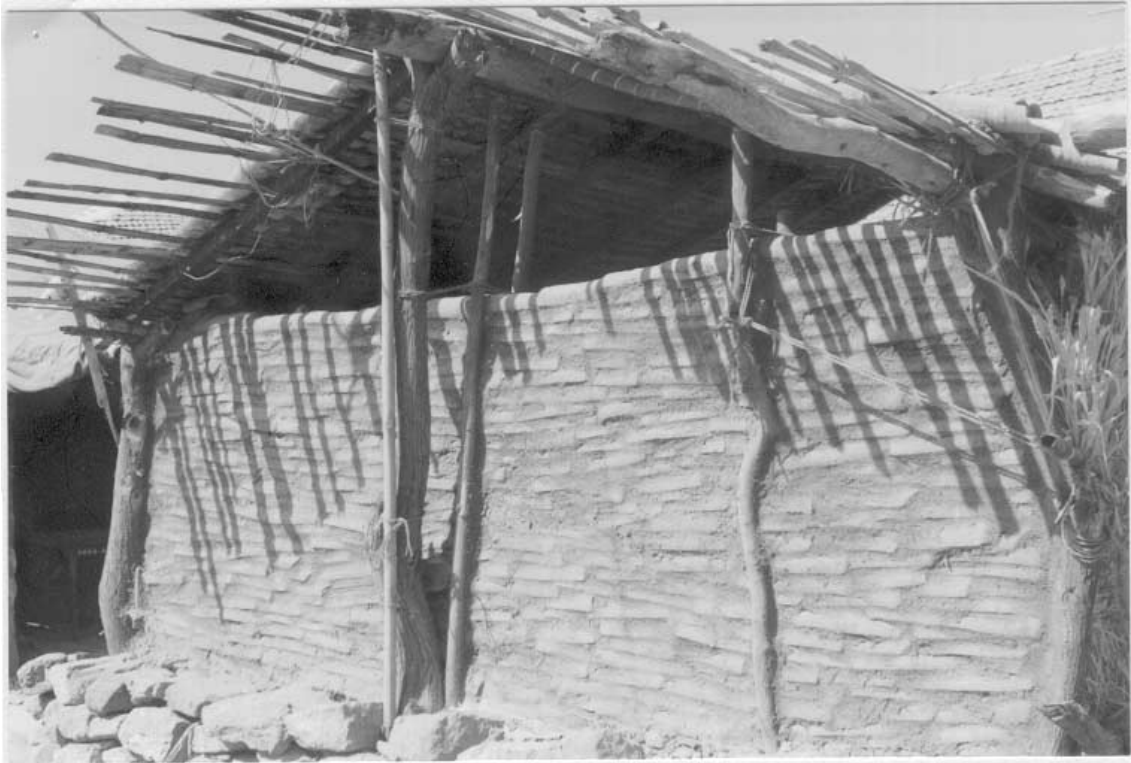
Figure 9. 'Naliyawali Deewal' (Jhadawas, Rapar taluk).

In the village of **Jhadawas**, an interesting structure with a very thin wall of about 12 cms thickness, locally called as 'Naliyawali Deewal' made out of country tiles was prevented from collapse by thin sticks on either face of the wall, held together by coir ropes. Figure 9 shows the details of the wall.

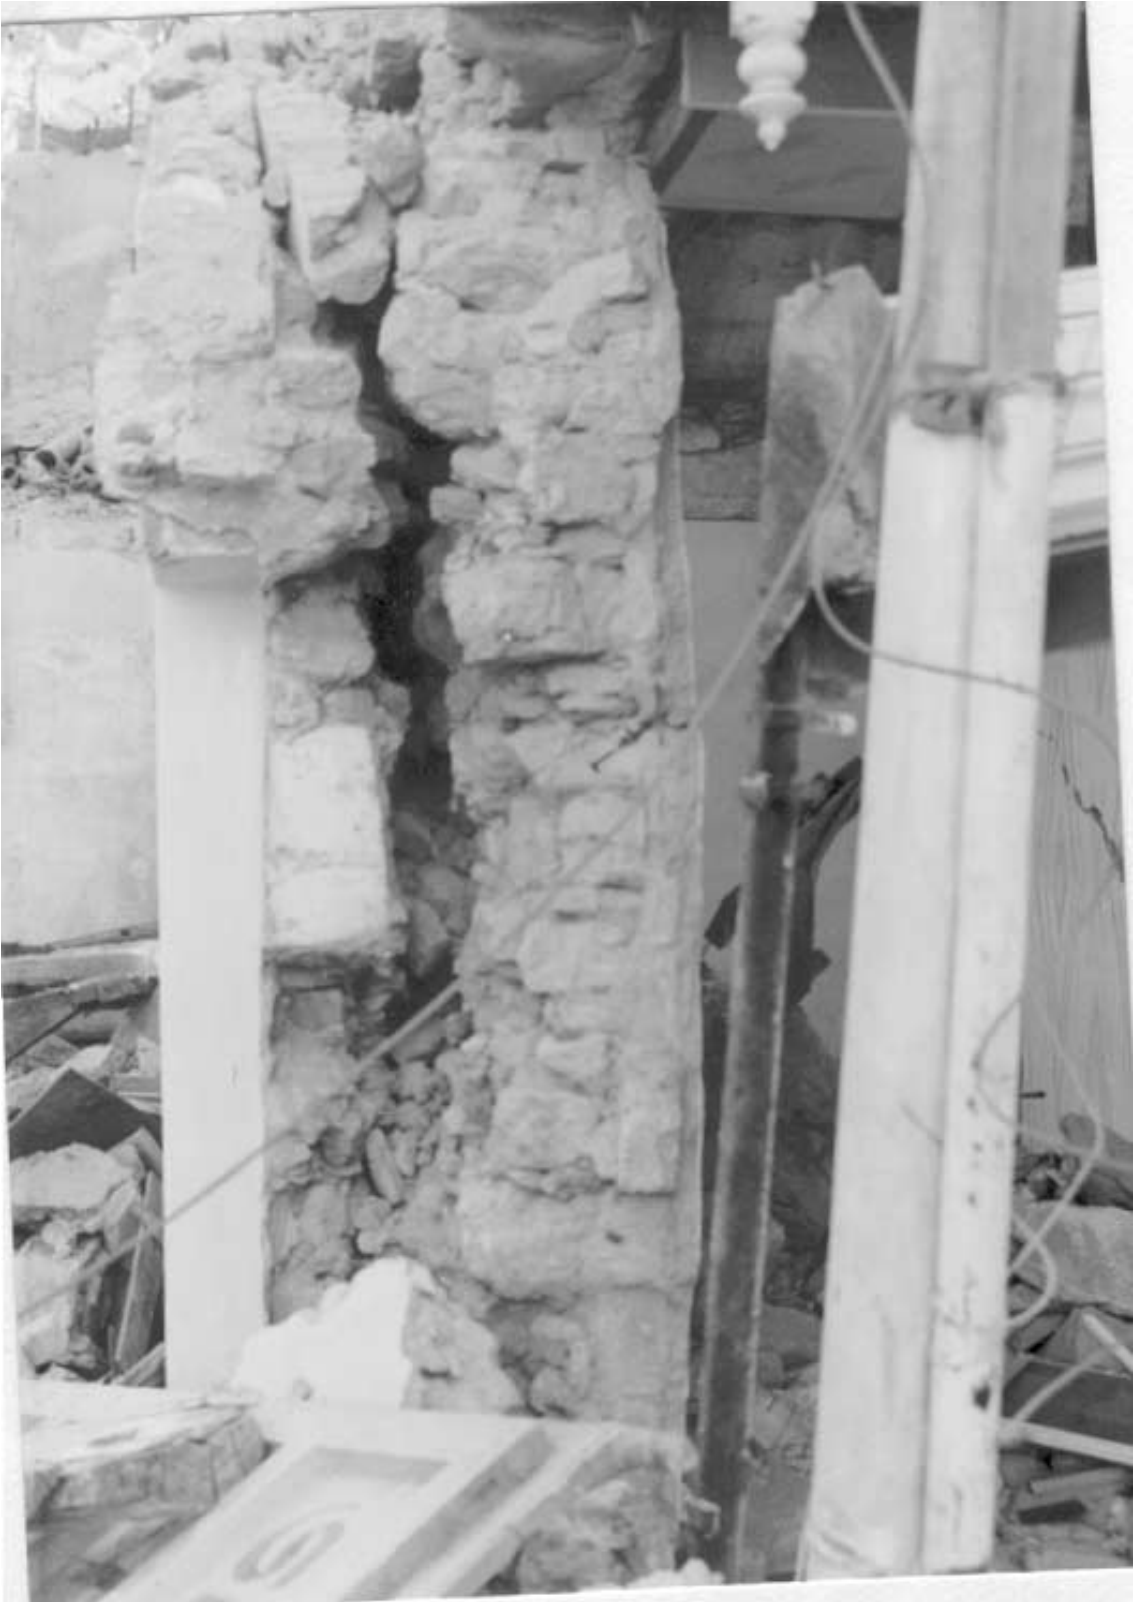
Figure 10. Delaminated wall with buckled wythes (Anjar).

- Masonry buildings in mud mortar or lime mortar are prone to severe damage due to lack of bond strength. Use of rounded stones in wythes without through-stones can further aggravate the problem. The failures of such structures are essentially due to out-of-plane flexure (figure 10).

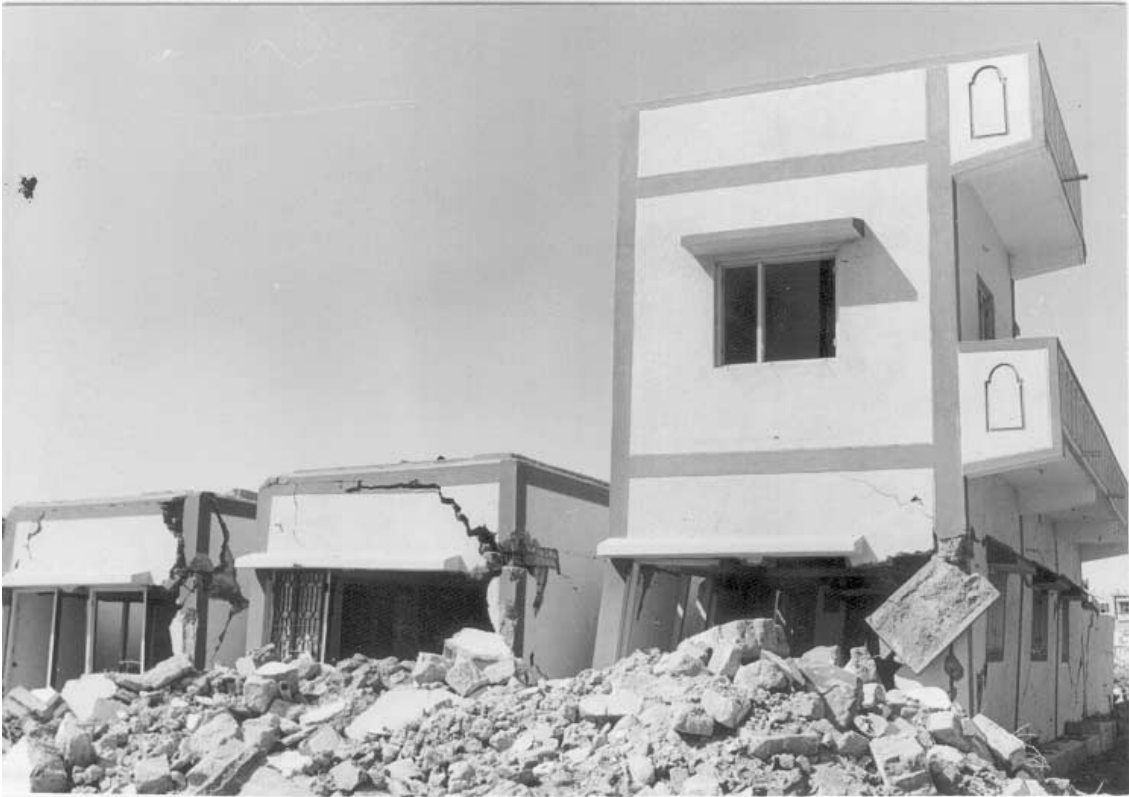
The damage at **Bachau** was indeed on an unprecedented scale. The entire town was practically razed to the ground. Total failure of stone-in-mud masonry buildings was seen. A couple of two-storeyed masonry buildings with lintel bands and corner columns had behaved similarly to the buildings in Samakhyali, the portion above the lintel band being almost intact.

Figure 11. Rigid box-like behaviour above lintel band (Bachau).
