Delineation of contaminant zone through electrical imaging technique

Ron Barker[†], T. Venkateswara Rao* and M. Thangarajan*[#]

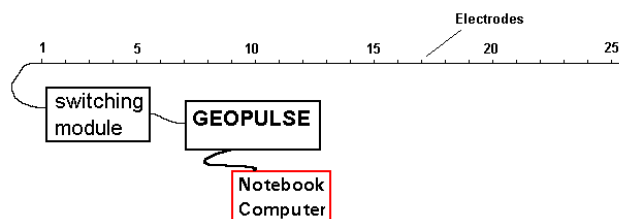
Figure 1. The basic instrument system employed in computer-controlled electrical imaging.

Modern field systems, such as the Campus Imager System, use a multicore cable to which 50 or more electrodes are connected at takeouts moulded at predetermined equal intervals. Such a cable is very much like a seismic cable and is used in a similar way. The cable is connected to a switching module, to an earth resistance meter and to a computer through an RS232 port (Figure 1). With these systems, any electrode may be switched to act as either

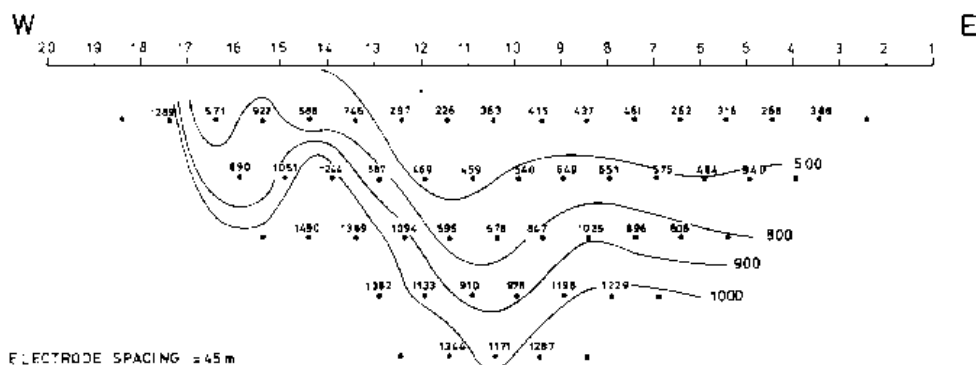
Figure 2. An example of a Wenner pseudo-section.

The first stage is the construction of a pseudo-section by plotting each apparent resistivity on a vertical section at a point below the centre of the four measuring electrodes and at a depth, which is equivalent to the median depth of investigation of the array employed^{2,3}. The data are contoured to form a pseudo depth-section, which qualitatively reflects the spatial variation of resistivity in cross-section (Figure 2).

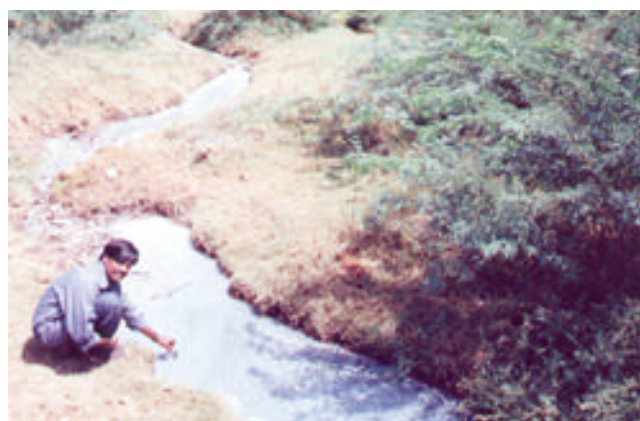
Figure 4. Untreated tannery effluents discharged through open channel.

The groundwater system in this area was contaminated due to untreated tannery effluents from 85 tanneries. Nearly 100 km² area of agricultural land was affected by the tannery pollution. Flow of untreated effluents is shown in Figure 4 and a contaminated well near the tannery site is shown in Figure 5.

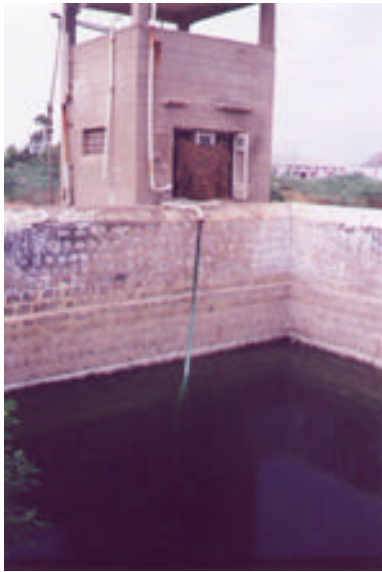
Figure 5. A contaminated well in the vicinity of a tannery.

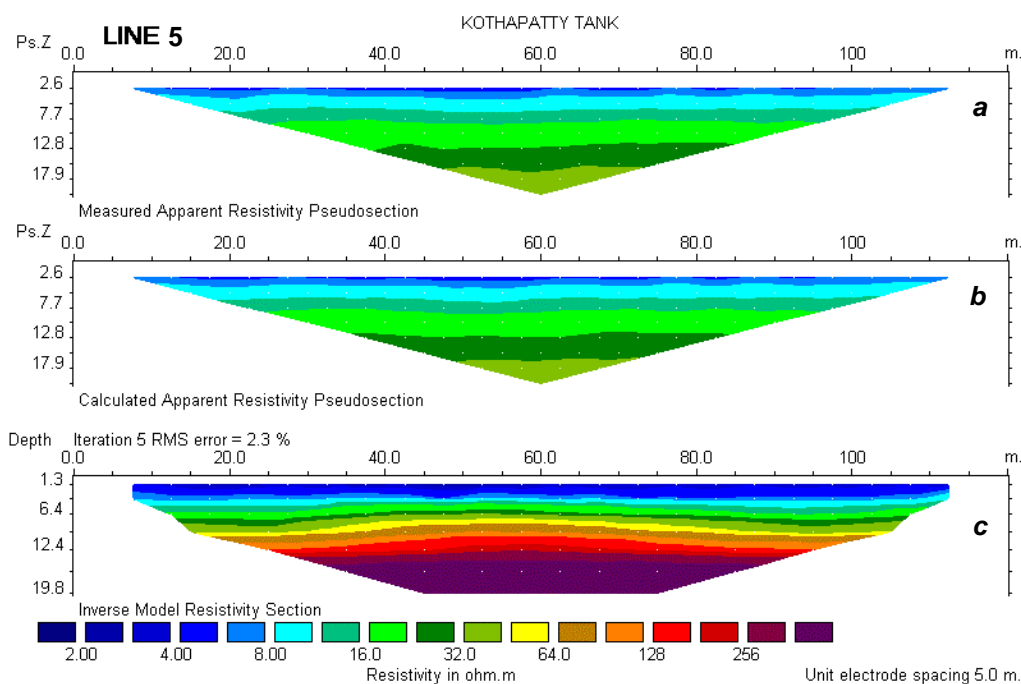
Figure 11. Electrical image along Line 5, Kottapatty tank.

Line 5 is almost a continuation of Line 4, but into the adjacent overflow of Kottapatty tank. The surface water in this tank also had high TDS of 12000 mg/l during April 2001. This is the main source of contamination to pollute groundwater as seen in Figure 11. The low resistivity at the surface reflects the presence of a thin layer of surface clay and contamination. However, the resistivity increases rapidly with depth, suggesting that contaminated water has not affected the sub-surface to the extent seen in the adjacent tank.
