Impact fatigue behaviour of carbon fibre-reinforced vinylester resin composites

Abstract. Two types of unidirectional carbon fibre, one of high strength (DHMS) and another of medium strength (VLMS) reinforced vinylester resin composites have been examined for their impact fatigue behaviour over 10^4 impact cycles for the first time. The study was conducted using a pendulum type repeated impact apparatus specially designed and constructed for the purpose. A well-defined impact fatigue behaviour (S–N type curve) curve has been demonstrated. It showed a plateau region of 10 – 10^2 cycles immediately below the single cycle impact strength, followed by progressive endurance with decreasing impact loads, culminating in an endurance limit at about 71% and 85% of the single impact strength for DHMS-48 and VLMS-48, respectively. Analysis of the fractured surfaces revealed primary debonding, fibre breakage and pull-out at the tensile zone of the samples and a shear mode of fracture with breakage of fibre bundles at the compressive zone of the samples. The occurrence of a few major macrocracks in the matrix with fibre breakage at the high load–low endurance region and development of multiple

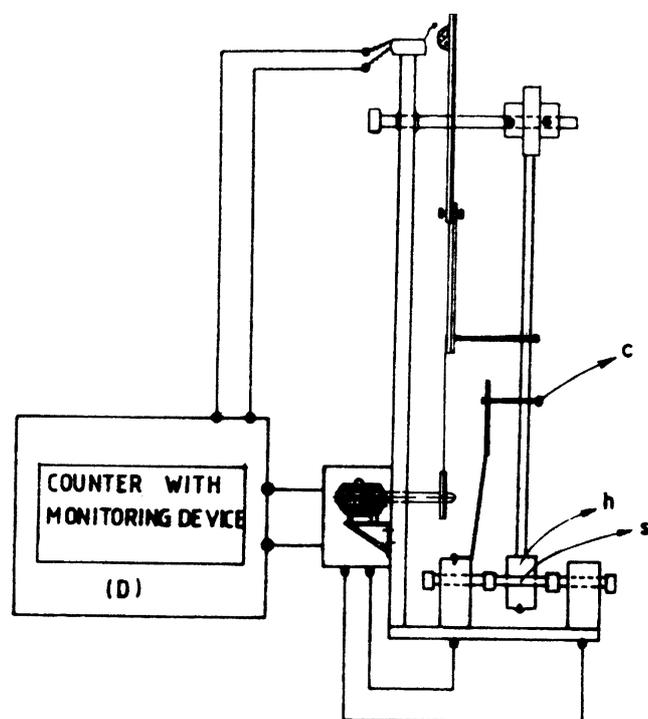
Figure 1. Schematic diagram of repeated impact fatigue apparatus.

A special swinging pendulum type impact fatigue tester (Sarkar and Glinn 1971; Maity and Sarkar 1995) based on the principles of Charpy Impact Tester was designed and fabricated in the laboratory (figure 1). It consists of a horizontal shaft to which was attached a rotating circular disc. The circular disc was rotated by a pulley and motor system. A pendulum hammer arm, with a cylindrical hammer (h), was attached to the other end of the horizon-

tal shaft. A trigger mechanism was fixed on one side of the circular disc that passed through the sensor once during each revolution, thus registering the number of impacts. A spring-loaded pick up arm, attached to the circular disc, carried the pendulum hammer up to a predetermined impact angle setting device (c) height during each revolution. Upon contacting the preset trigger the pick up arm retracts allowing the pendulum arm to drop onto the specimen (s) held horizontally between two tapered conical cups, screw mounted on the platforms. After each impact the free hanging hammer was picked up to the impact angle setting device again and then released till the specimen fractured, and the number of impacts to fracture was recorded by means of a 6-digit electromagnetic (resettle) counter. The specimen grips were wired into an electrical circuit with a monitoring device (D), which, when broken, stopped the machine. Impact frequency was set at 6 impacts/min demonstrated schematically in figure 2.

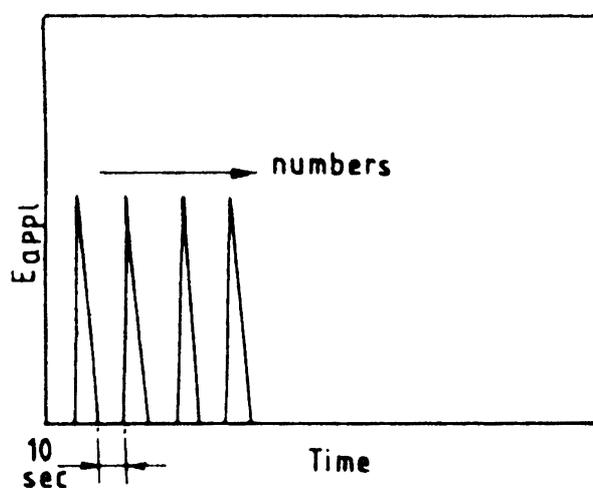
Figure 2. Schematic representation of the frequency of applied impact energy (E_{appl}) with time (t).

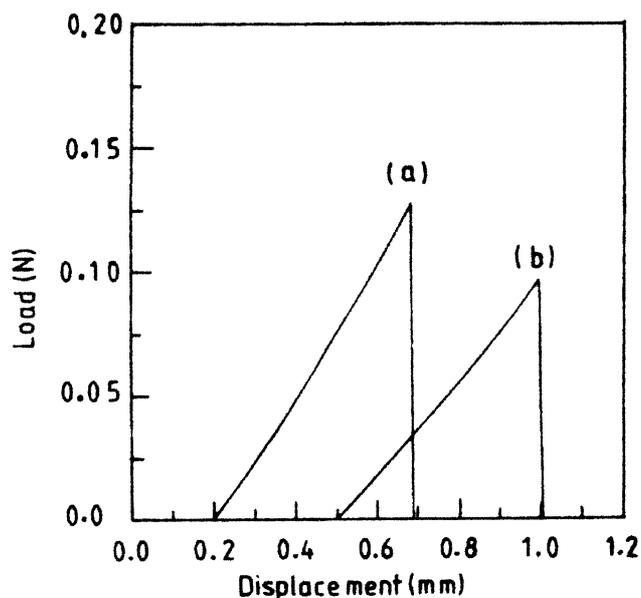
Figure 3. Load-displacement curves: (a) DHMS fibre and (b) VLMS fibre.

The load displacement curves for (a) DHMS carbon fibre and (b) VLMS carbon fibre are shown in figure 3. The DHMS fibres broke at a maximum load of 0.1303 N whereas the VLMS fibres broke at 0.0991 N load.

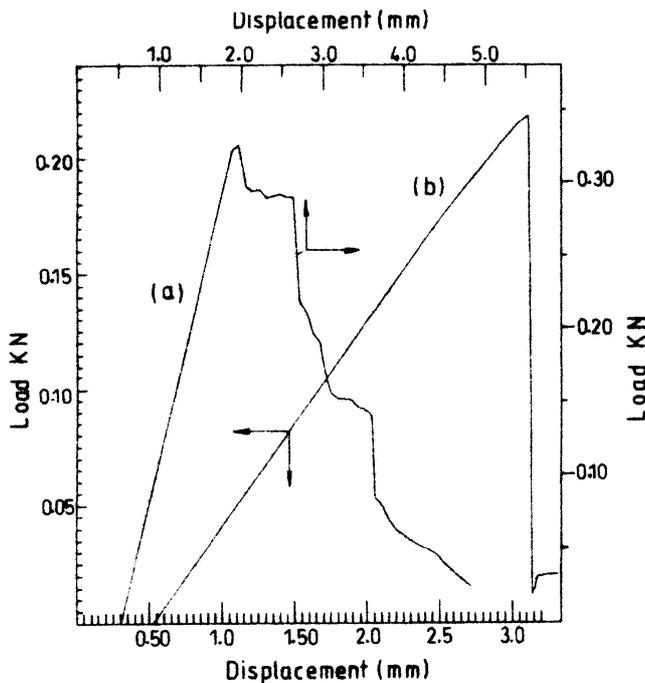
Figure 4. Load-displacement curves: (a) DHMS-48 composite and (b) VLMS-48 composite.

Typical load-displacement curves for (a) DHMS-48 composite and (b) VLMS-48 composite are compared in figure 4. Examinations of load-displacement curves showed a substantially different picture between the two sets of composites. The displacements at the breaking loads were about 2 mm for DHMS-48 and 3.2 mm for VLMS-48 composites before final fracture. The curve for

DHMS-48 exhibits a linear elastic increase up to the maximum load of 0.33 KN, followed by a small drop in strength of 617.8 MPa. This is indicative of the onset of matrix cracking, debonding and a few fibres fracture. The load then dropped sharply with fibre fracture and pull-out. In contrast, the load for the VLMS-48 composites dropped off sharply after the peak load at 0.23 KN to a total fracture. The work of fracture or the rupture energy at the peak load for the two sets were 25.71 KJ/M² and 22.54 KJ/M² respectively.

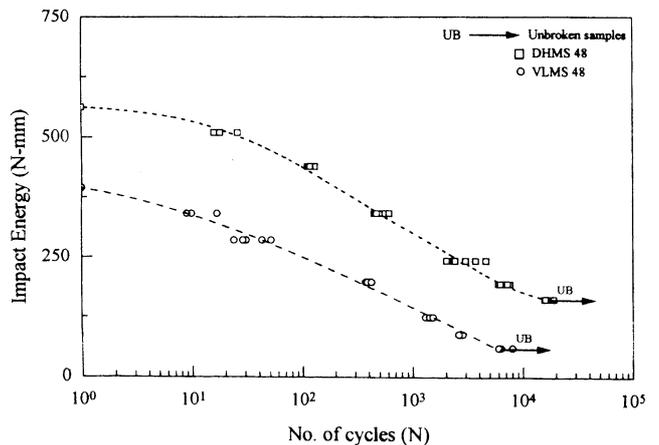
Figure 5. Impact energy vs. no. of cycles (N) curves for DHMS-48 and VLMS-48 composites.

The critical impact strength for DHMS-48 was 562.6 N-mm against 394.6 N-mm of VLMS-48. On reducing the applied impact energy the composite samples sustained progressively larger numbers of impacts. The fatigue results obtained for both the carbon fibre reinforced composites are depicted in figure 5. A typical S-N type curve is evident having progressive endurance with decreasing applied impact loads. In conformity with Gamstedt and Talreja (1999) the curves essentially displayed three regions having a plateau (region I) at the higher impact loads followed by progressive increase in endurances with decreased impact loads (region II) to an endurance limit (region III) at 160.5 N-mm for DHMS-48 composite and 60.1 N-mm for VLMS-48 composites after impact fatigued to about 10⁴ cycles. The ratio E_I/E_c for DHMS-48 was 0.29 while for VLMS-48 it was 0.15, where E_I is taken as the applied impact energy at endurance limit and E_c the single impact (critical) energy value. The difference in fatigue behaviour between the two varieties of composites is better demonstrated when the ratio of the applied subcritical impact energy (E_I) to

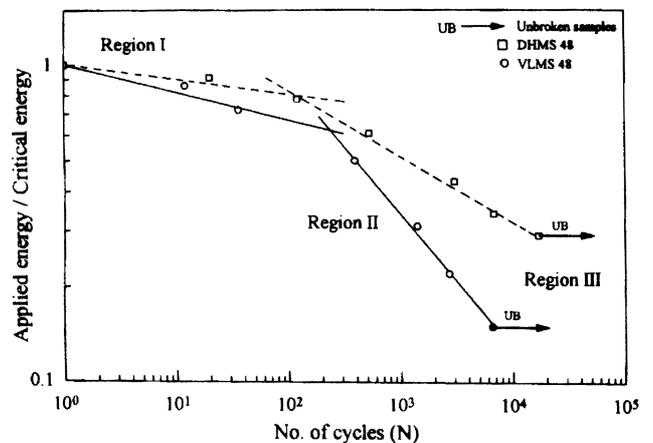
Figure 6. Ratio between applied impact energy and critical impact energy for DHMS-48 and VLMS-48 composites.

critical impact energy (E_c) against number of cycles is plotted and is shown in figure 6. The fatigue behaviour of the DHMS-48 composite was thus found to be superior to that of VLMS-48 composite owing to the superior fibre properties in the former. A clear deflection at around 10² impact cycles from a shallow to a sharp drop was evident. The shallow drop in fatigue behaviour in region I is similar to the study made by Gamstedt and Talreja (1999).

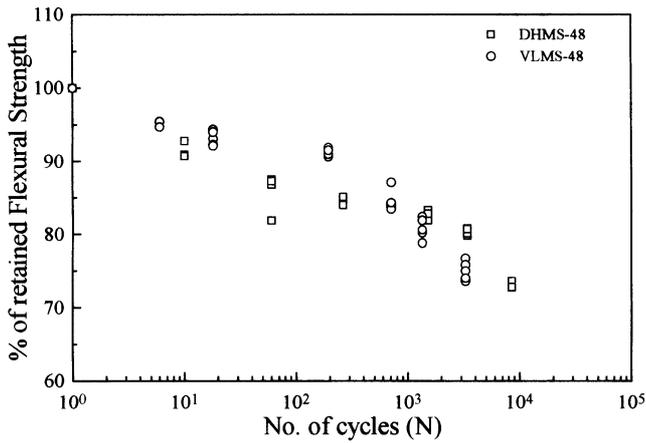
Figure 7. Residual flexural strength (%) after 50%-N for DHMS-48 and VLMS-48 composites.

The unbroken impact fatigued samples at about 50% of the endured number of cycles (50%-N) at each subcritical impact loads were measured for their residual strength, modulus and toughness properties in an INSTRON 4303 machine in accordance with ASTM D790M-81. The results are shown in figures 7-9. At 160.5 N-mm impact energy level where the DHMS-48 specimens endured about 8431 impact cycles (region III) without breakage, there had been a decrease of the residual strength by about 27%, modulus by 11% and toughness by 27%. At the lowest impact energy level of 60.1 N-mm, the VLMS-48 specimens endured about 3256 impact cycles (region III) without

breakage and there had been a decrease in the residual strength by 25%, modulus by 18% and toughness by 35%. Although there had been a drop in properties, yet the composites sustained the fatigue loading without failure. The drops in the % residual strength properties for both the composites were virtually the same but a difference was observed for % modulus and % toughness properties, the VLMS-48 composites having lower retained properties than the other. This could be attributed to the predominantly direct fracture of the fibres preceded by debonding and matrix cracking without much intermediary failure steps. Unlike Wyrick and Adams (1988) the drop in the properties were relatively less till large number of impacts were endured.

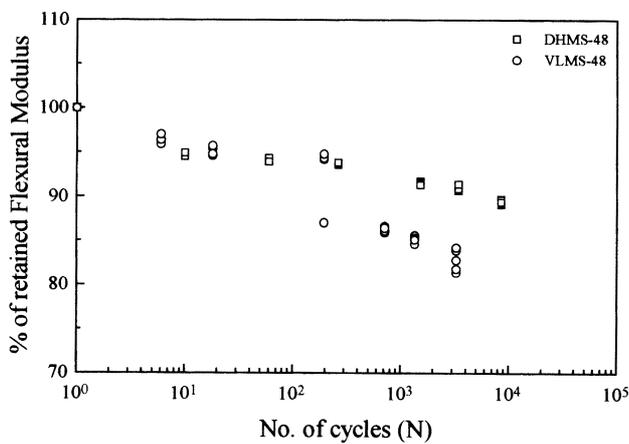
Figure 8. Residual modulus (%) after 50%-N for DHMS-48 and VLMS-48 composites.

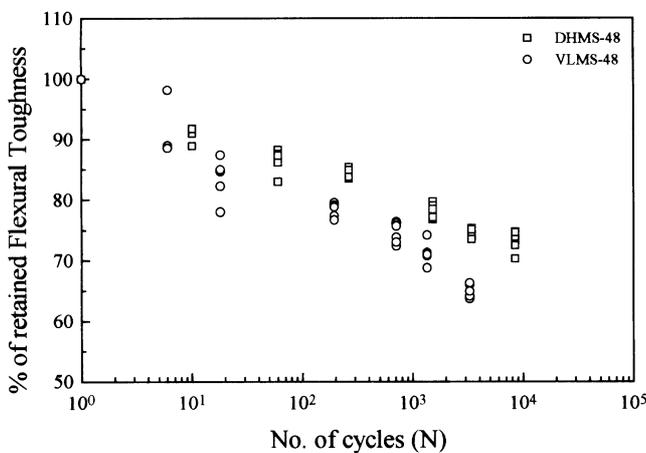
Figure 9. Residual toughness (%) after 50%-N for DHMS-48 and VLMS-48 composites.

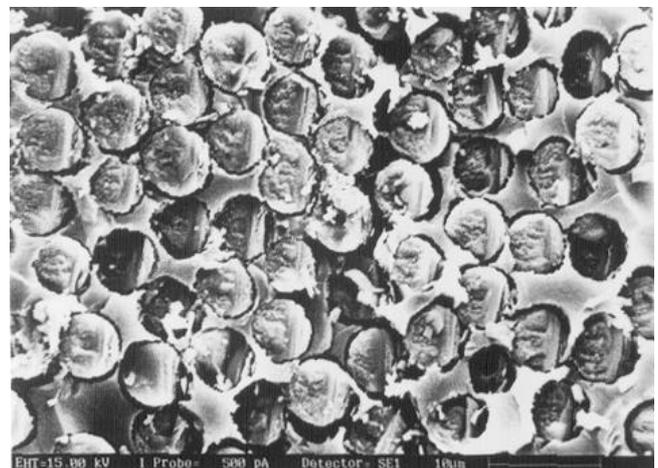
Figure 10. SEM photograph of DHMS-48 composite showing interface debonding and a shear type of fracture under single impact energy of 562.0 N-mm.

matrix was observed for both types of composites examined indicating that the technique adopted to process the samples were satisfactory, eliminating much of the composite weaknesses contributed by the defects incorporated during processing. DHMS-48 composites under flexural test showed heavy debonding with fibre pull-out and fracture at the tensile zone and shear fibre bundle fracture at the compressive zone in conformity with the load-displacement curve shown in figure 4. Samples when broken under single impact for DHMS-48 at an impact energy level of 562.3 N-mm (figure 10) showed a continuous debonding followed by a shear breakage of the fibre bundle. On the other hand, for VLMS-48 samples broken under single impact at an impact energy level of 394.6 N-mm, showed a debonding with shear breakage of the fibre bundle as well as the fibre pull-out (figure 11). In region II, at the energy level of 340.4 N-mm and 197.1 N-mm, the fracture surfaces of DHMS-48 and

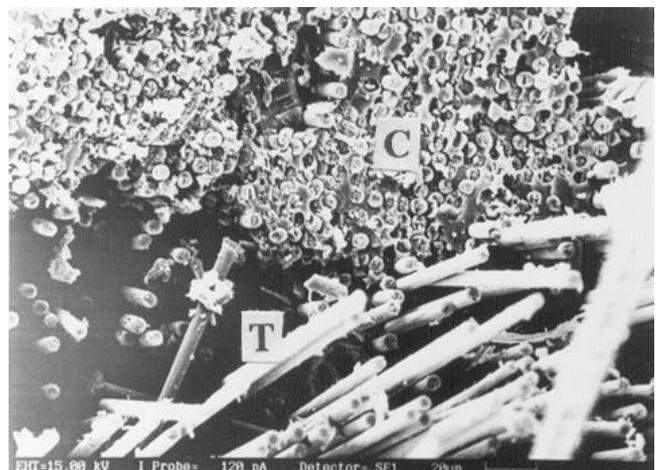
Figure 11. SEM photograph of VLMS-48 composite broken under single impact showing debonding as well as the fibre pull-out.

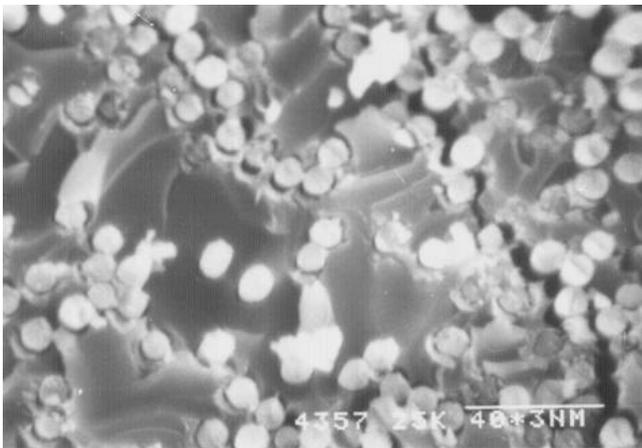
Figure 12. SEM photograph of DHMS-48 composite showing a propagating matrix crack along the interface ($E_{\text{appl}} = 340.4$ N-mm, $N = 502$ cycles).

VLMS-48 samples respectively, showed debonding and matrix cracking (figures 12 and 13). In region III, under impact fatigue at 160.4 N-mm energy level the fracture surfaces of DHMS-48 showed (figure 14) matrix cracking with fibre pull-out. The VLMS-48 samples displayed similar fracture behaviour under fatigue conditions at the energy level of 60.1 N-mm (figure 15). In conformity with Gamstedt and Talreja (1999) the failures of the composites followed a set pattern of debonding and crack initiation of the matrix at the plateau region I propagating along the fibre-resin interface. As the samples endured more impacts, the damage in the form of debond and matrix cracking multiplied eventually affecting the fibres leading to fracture. The later is more predominant when the samples were fatigued for a large number of cycles beyond 10^3 cycles. This is reflected in the measurements of the residual properties at 50%-N. The matrix cracking and debonding were more effective on the flexural

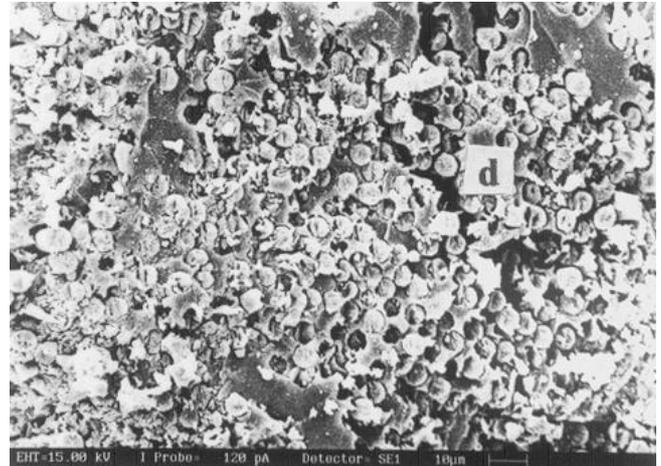
Figure 14. SEM photograph of DHMS-48 composite showing a combined failure having debond cracks, fibre fracture and pull-out ($E_{\text{appl}} = 160.5$ N-mm, $N = 16500$ cycles, $d =$ debonding).

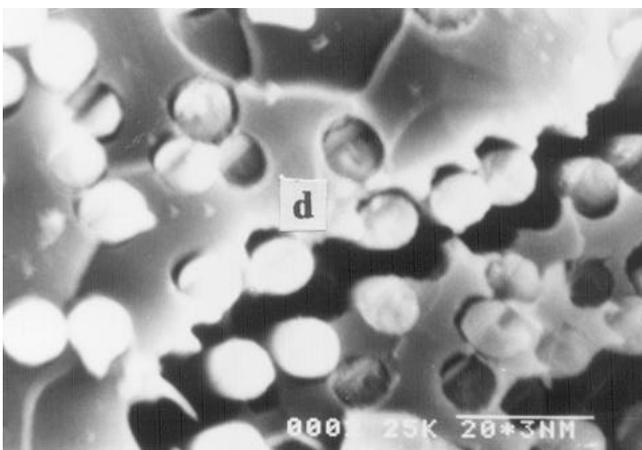
Figure 13. SEM photograph of VLMS-48 composite showing matrix cracking and debonding ($E_{\text{appl}} = 197.1$ N-mm, $N = 390$ cycles, $d =$ debonding).

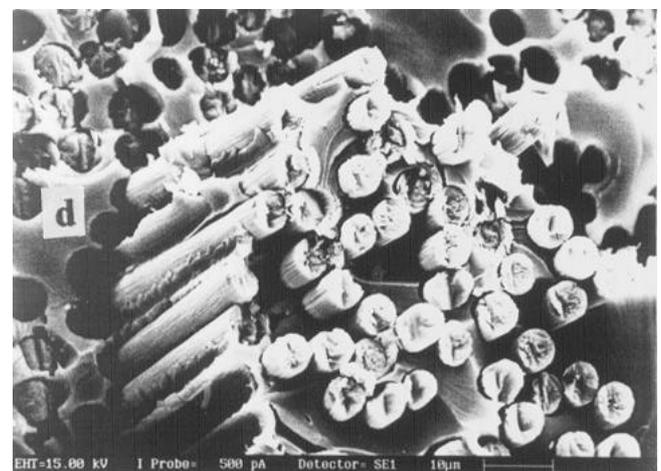
Figure 15. SEM photograph of VLMS-48 composite showing fibre fracture and pull-out ($E_{\text{appl}} = 60.1$ N-mm, $N = 6000$ cycles).
