On materials science aspects of impact of cannon ball on the stability of the Delhi Iron Pillar

R. Balasubramaniam

Department of Materials and Metallurgical Engineering, Indian Institute of Technology, Kanpur 208 016, India

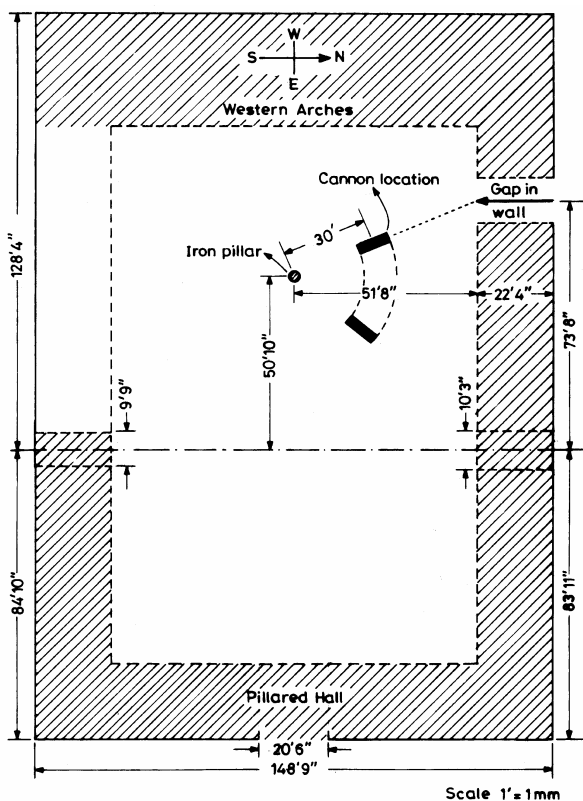
Figure 2. Plan of the Quwwat-ul-Islam mosque showing the salient dimensions of its premises and the possible location of the cannon that fired the shot.

the cannon ball may have reached the pillar's surface after having been lobbed over the mosque boundary.

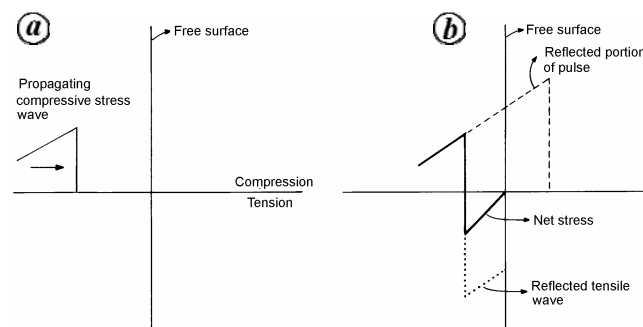
In particular, it is important to consider the reflection of shock waves due to the free surface, to understand the nature of cracking seen on the side and rear side of the cannon ball indentation area. Reflection of stress waves generally occurs at the free surface and fixed ends, at changes in the cross-section and at discontinuities within the solid¹⁸. The effect of shock waves on material fracture can be understood¹⁸ by considering Figure 5. A compressive shock wave propagates through the solid and approaches the surface from left to right (Figure 5 *a*). At the free surface, the wave is reflected back as a tensile wave from right to left (Figure 5 *b*). Therefore, the net stress is obtained at this location by summing up the incident compressive stress and the reflected tensile stress. It is noted that there is rapid build-up of tensile stress as the wave is reflected back from the free surface (Figure 5 *b*). When this tensile stress reaches a high enough value, fracture occurs.

Figure 5. (a) Propagation of compressive stress wave and (b) reflection as a wave from the free surface resulting in net tensile stress near the free surface.
