# Isoseismals for the Kutch earthquake of 26th January 2001

A SINVHAL<sup>1</sup>, P R BOSE<sup>2</sup>, V PRAKASH<sup>1</sup>, A BOSE<sup>3</sup>, A K SARAF<sup>4</sup> and H SINVHAL<sup>4</sup>

Damage observed during the Kutch earthquake of 26th January 2001 is classified according to the type of structure. This damage pattern has been used to draw the isoseismal map on the basis of the intensity scale given in IS 1893–2002 which covers only traditional one to two storey houses. Having thus estimated intensities, and observed damage to other types of structures, a new criterion was adopted which is included in this paper. Areas that showed maximum damage to structures have been assigned maximum intensity X.

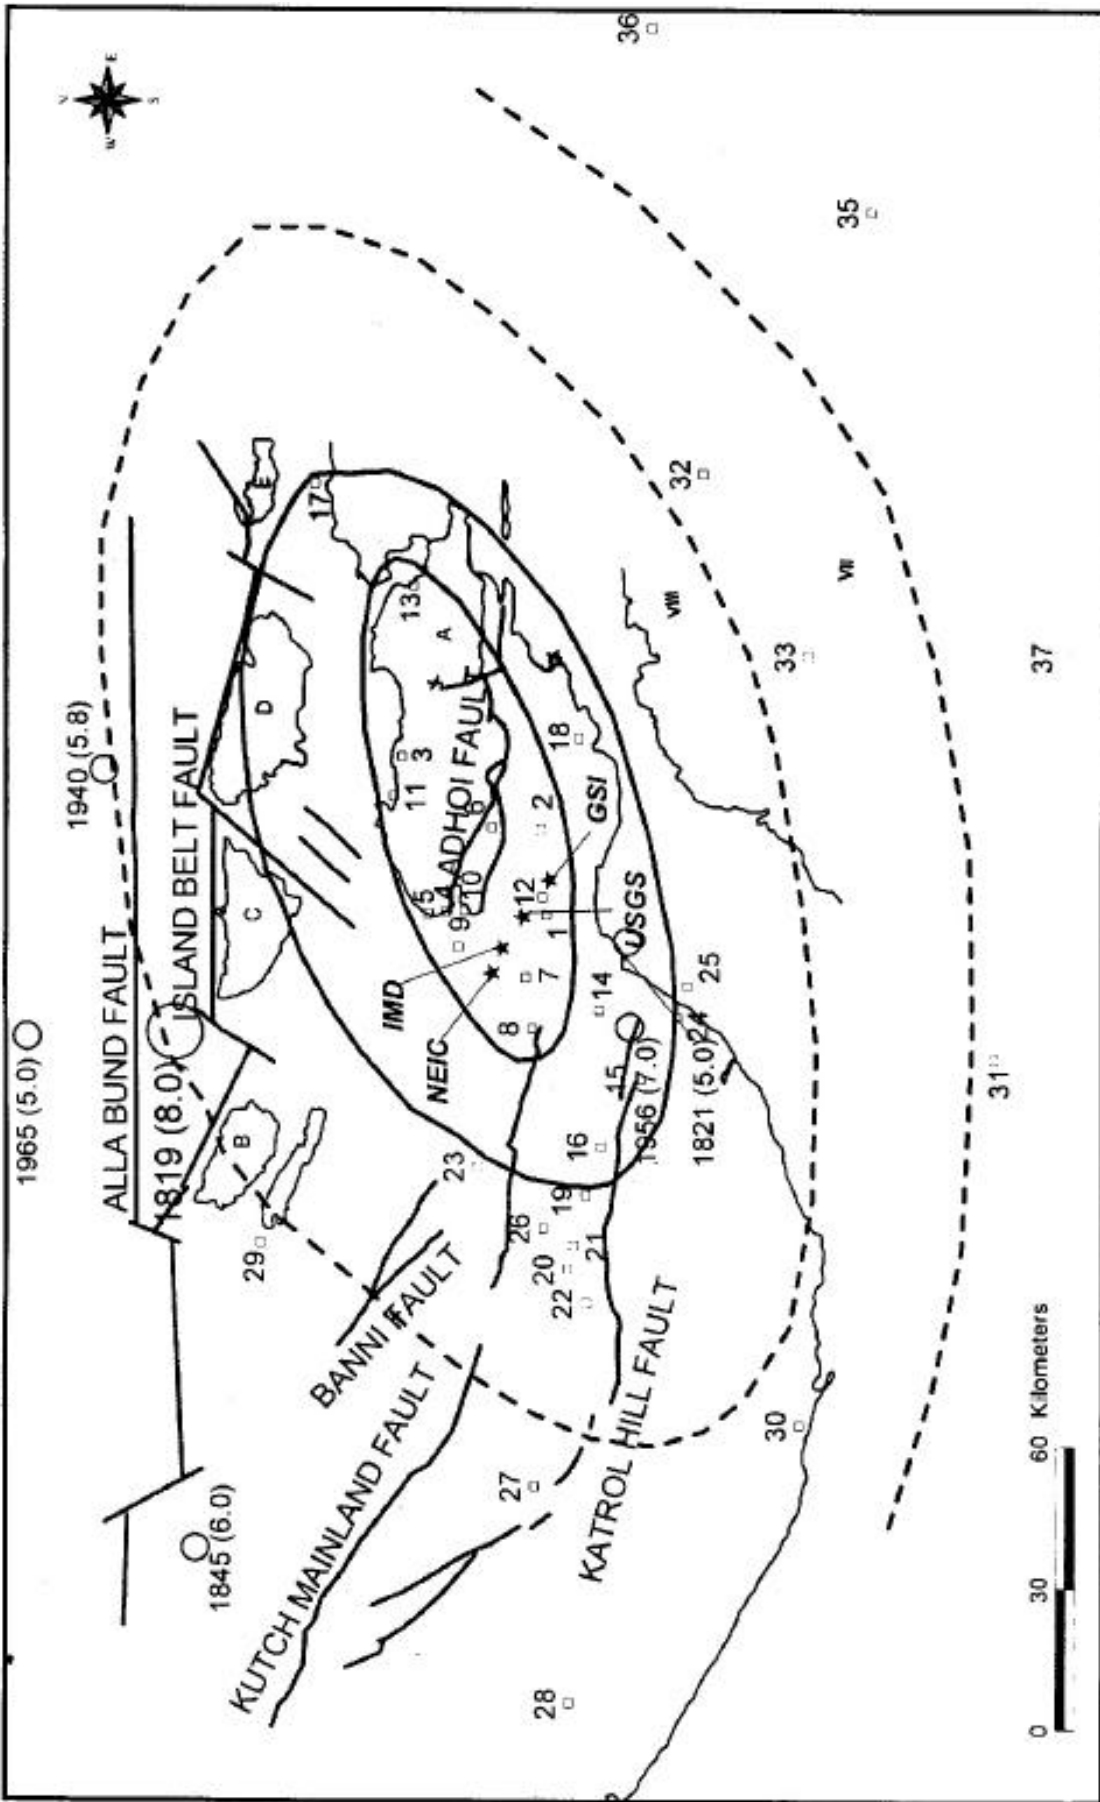
The isoseismal map (figure 1) for the Kutch earthquake of January 26th, 2001 (m 6.9) was drawn on the basis of a composite damage survey of several kinds of buildings. These included houses in rural and urban areas and reinforced concrete buildings of schools, hospitals, community inns and government offices. The survey also included temples; 4–6 storey buildings; infrastructure buildings such as overhead water tanks, substations of Gujarat Electricity Board, roads, bridges, industrial buildings and oil installations; and ground damage (Bose *et al* 2001; Prakash *et al* 2001 (a,b,c,d,e,f); Saraf *et al* 2001, 2002; Sinvhal *et al* 2001 (a,b,c,d,e,f,g) 2002). For each type of structure it was important to judge the quality of construction and the presence of critical deficiencies. No landscape changes, barring soil-liquefaction, were observed anywhere, and therefore the maximum intensity assigned is limited to X.

Figure 1. Isoseismal map for the Kutch earthquake of January 26th, 2001, superposed on the tectonic map of Kutch (after Biswas and Deshpande 1983). A: Wagad Ridge, B: Paccham Uplift, C: Khadir Uplift, D: Bela Uplift, E: Charor Uplift. Stars show epicenters of this earthquake provided by different organizations. Locations of important places of the affected area are numbered and referred to in tables 2 and 3. Circles show epicentres of previous earthquakes in the region.
