Severe wear behaviour of alumina balls sliding against diamond ceramic coatings

ANURADHA JANA^{1,2}, NANDADULAL DANDAPAT¹, MITUN DAS¹, VAMSI KRISHNA BALLA¹, SHIRSHENDU CHAKRABORTY¹, RAJNARAYAN SAHA² and AWADESH KUMAR MALLIK^{1,*}

¹CSIR–Central Glass & Ceramic Research Institute, Kolkata 700032, India

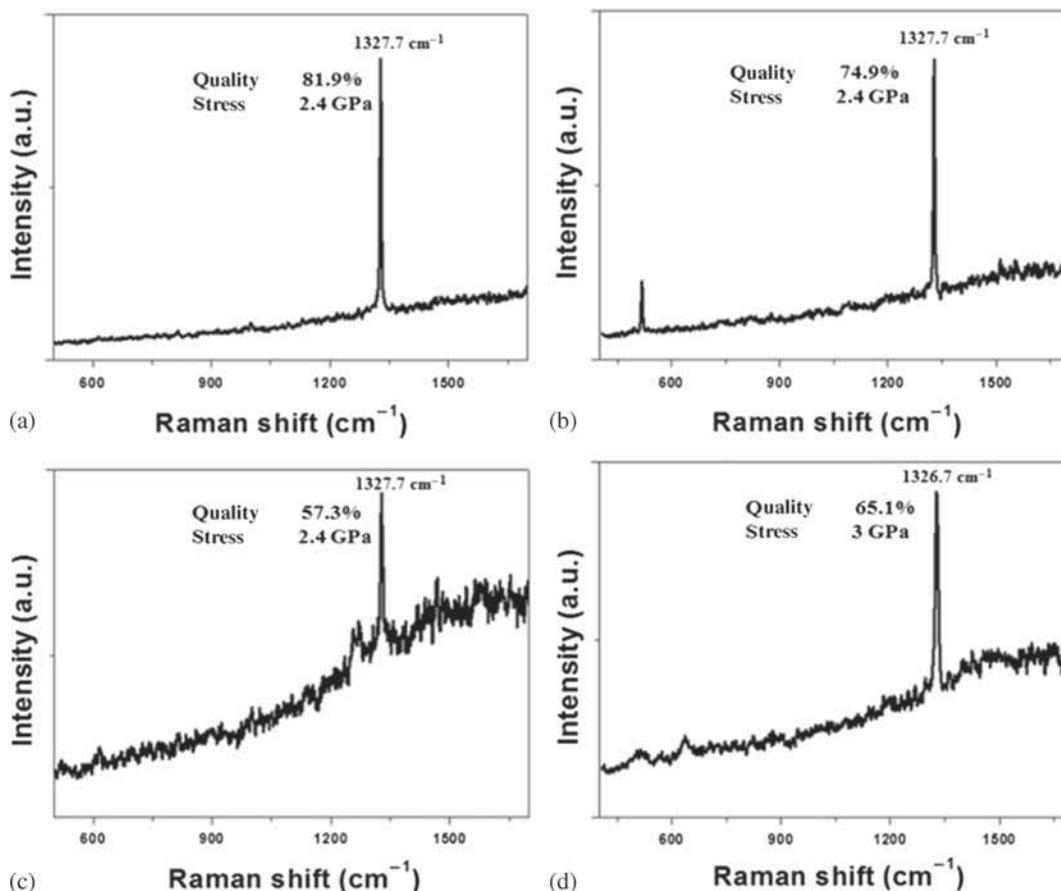
Figure 1. Raman spectra of (a) W11, (b) W14, (c) W13 and (d) W23 samples.

3.1b Quality and stress: Four types of samples were deposited with different CH_4 flow percentages and different deposition times. The quality and stress present inside the diamond samples have been measured from Raman peak shift as shown in figure 1. It was found that the quality of the diamond coating decreases with increase in CH_4 concentration. The quality of W11 and W14 samples were almost same since identical CH_4 percentage (1%, table 1) had been used. On the other hand, the quality of the W13 sample (2.5%) was not better than W23 sample (2%) due to usage of higher CH_4 percentages (table 1). Mallik *et al* [45] had studied that the quality of PCD coating deteriorates with an increase of the CH_4 percentage on H_2 . Residual stress arises in the PCD coating due to thermal expansion coefficient mismatch with the base silicon substrate [46]. It is found that W11, W13 and W14 samples have similar tensile stress present in the regions where the Raman signals were taken from. The tensile stress arises due to growth defects like dislocation, vacancy, twin, etc. present inside the growing crystals. Identical values of the stress indicate that there was an identical down shift of the Raman peak in the signals from the diamond coating. To explain this similar down shift, it would be interesting to note that W13 and W14 samples were grown for very less number of hours. But on the other hand, W11 was grown for almost 10 days. Although W11 was grown for 239 h, the Raman signals were taken from the nucleation side of the freestanding coating. The nucleation side after removal of the base substrate would not have any thermal stress. Nucleation side would only possess the stress due to the presence of growth defects. And, it is very obvious that the nucleation side would have growth defects which are typical for initial growth and nucleation period of the CVD run. Now W13 and W14 were also grown for less number of hours, so it may be expected that they would also possess the similar growth defects which are typical of initial growth and nucleation period of the CVD run. The identical stress values of W11, W13 and W14 indicate that they had similar kind of CVD growth defects responsible for the identical tensile stress of 2.4 GPa. On the other hand, W23 was deposited for 25.5 h, producing quite a thick coating, which not only had the presence of growth defects from initial nucleation period of the CVD run, but also it had additional number of defects which increased the total down shift of the Raman peak and thereby the intrinsic tensile stress went up to 3 GPa.

COF values of the samples were lower in SBF environment, as SBF solution gave some lubricating effect under sliding contact. From the literature it is known that water has some lubricating effect on the nano-crystalline diamond coating and reduces the COF value [49]. SBF solution also contains water, so in effect this solution may reduce the COF value. Again, it is observed that the W11 and W14 samples give higher COF in SBF environment at both the applied loads than the as-grown samples W13 and W23 (may be because of higher Q -factors as shown in figure 1).

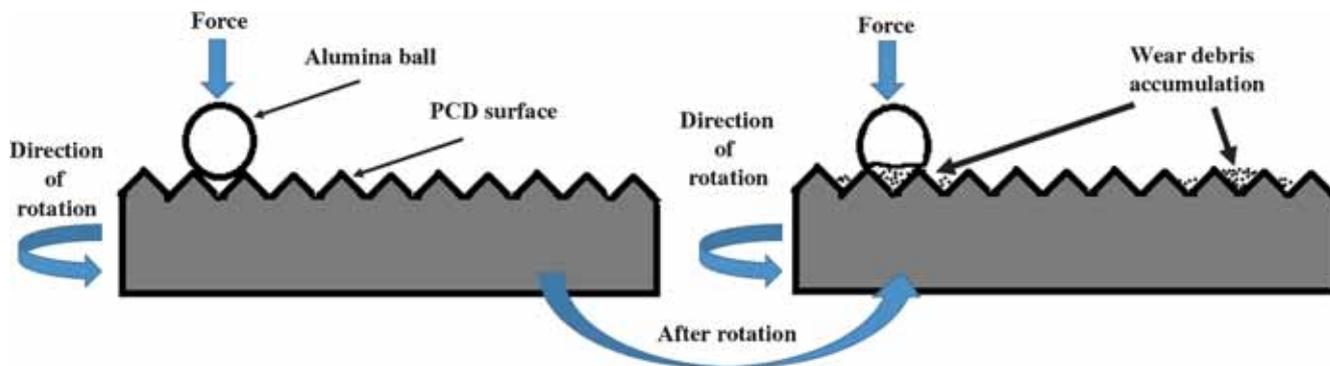
Figure 2. Schematic of wear mechanisms of alumina ball on the PCD surface.

motion, and the alumina ball came in direct contact with the high asperities of the PCD surface, where microscopic wear takes place (figure 2). The coefficient of friction was high at the beginning of the experiments due to static friction and after a certain time period it reduces to lower values due to dynamic friction. Friction curves are shown in figure 3.

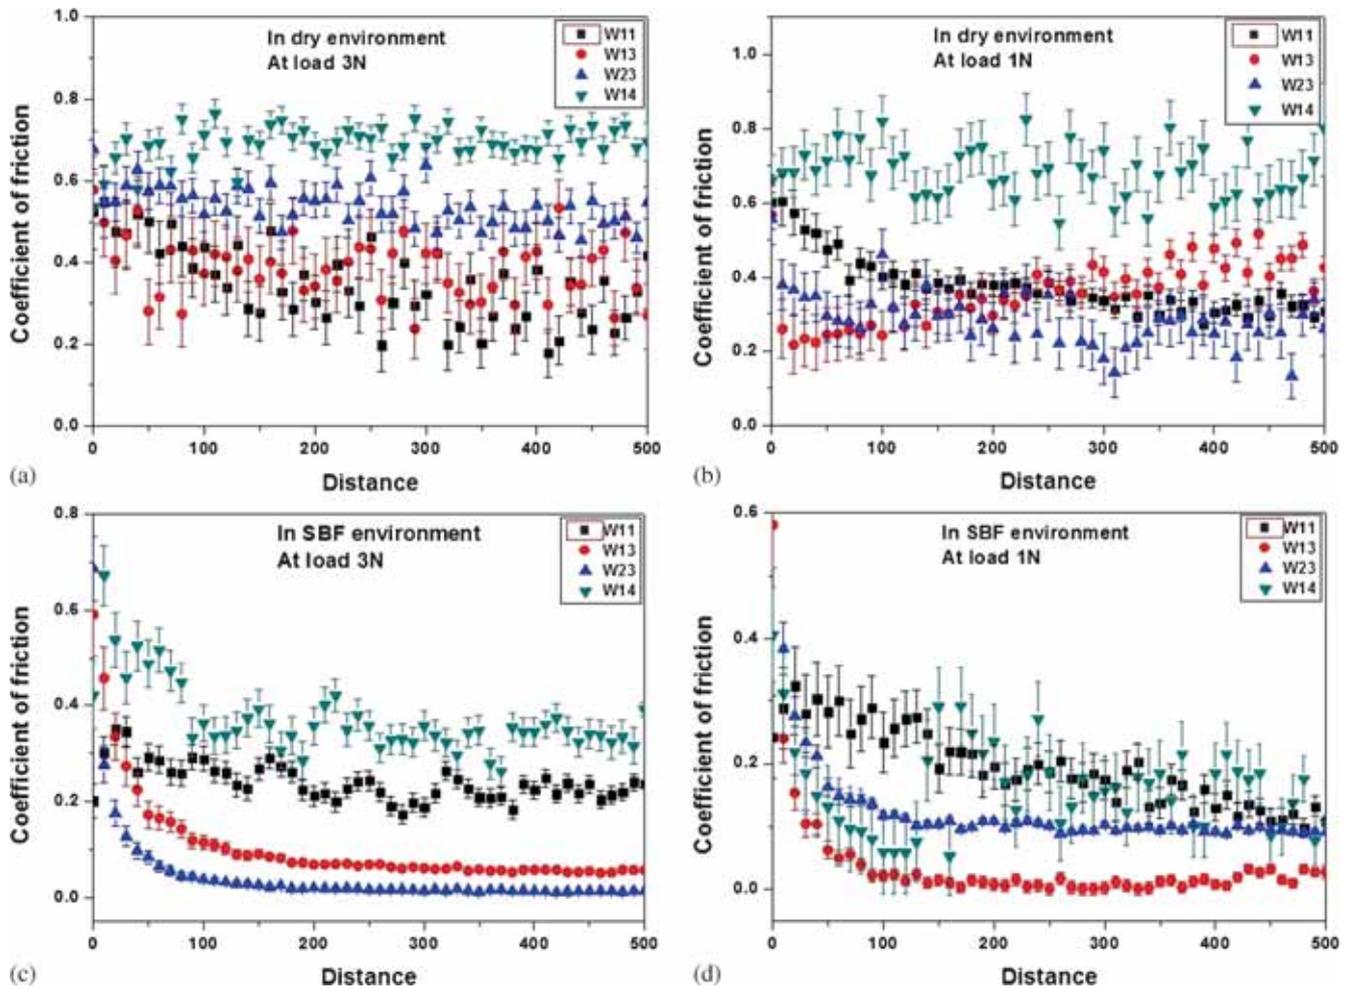
Figure 3. Friction curves of W11, W13, W14 and W23 (a) at 3N and (b) 1N load in dry environment and (c) at 3N and (d) 1N load in SBF environment.

with decrease of their roughnesses. In the dry environment at 1N load (figure 3b), W14 shows the highest COF but W23 sample shows the lowest COF though it has the highest roughness. In the SBF environment at 3N load (figure 3c), W14 sample shows the highest COF value though the sample had the lowest roughness and W23 shows the lowest COF value though it has the highest roughness value. W11 sample shows higher COF in SBF environment at 1N load (figure 3d).

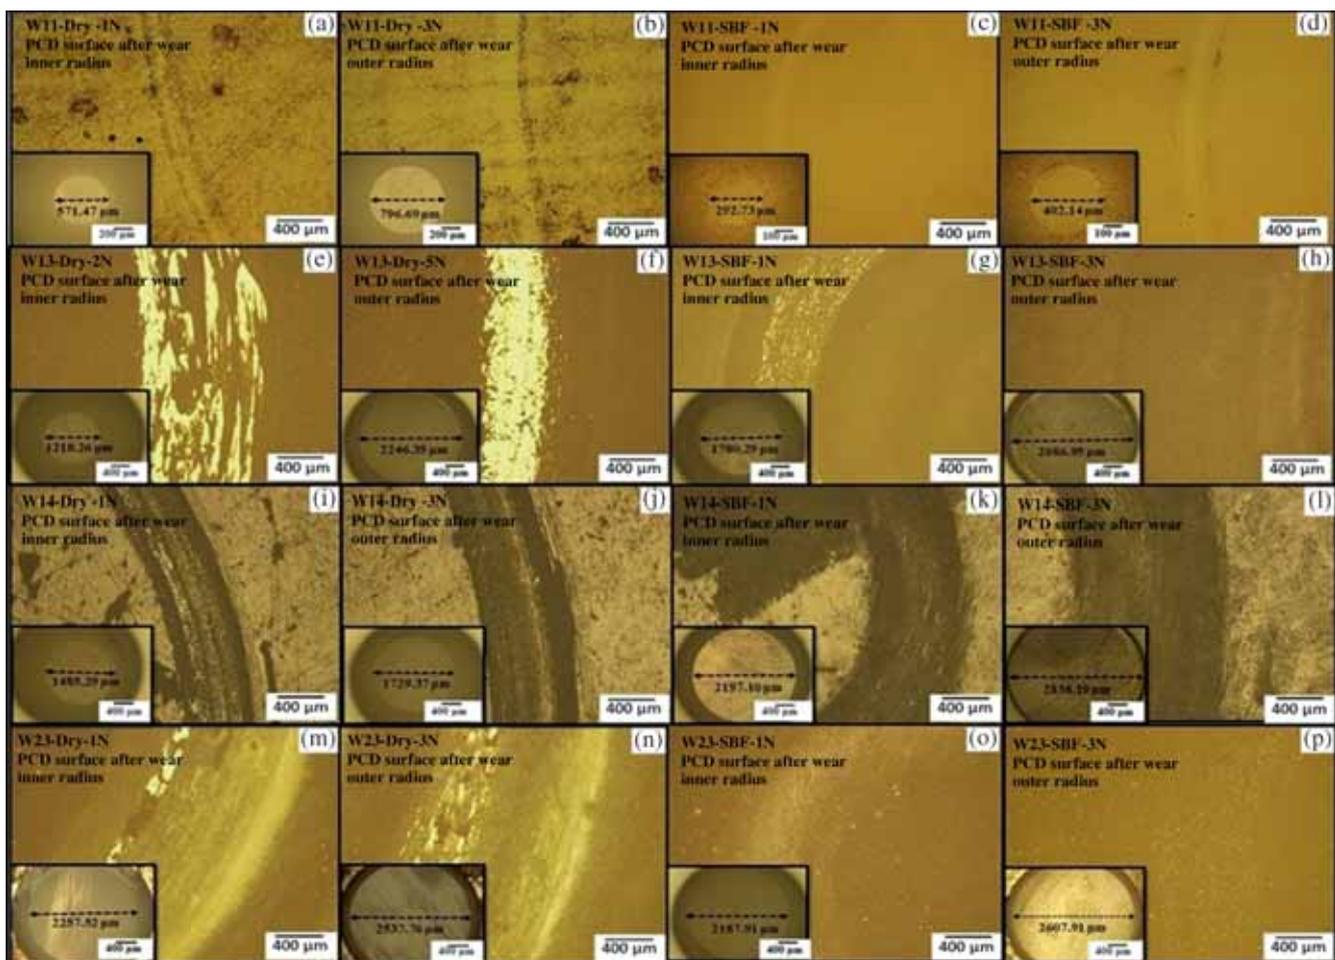
Figure 4. Optical microscope images of the wear tracks on PCD surfaces with the inset images of the worn out alumina balls.

3.2b Wear observed under optical microscope: After the tribology experiments, the worn out alumina balls and the PCD surfaces were observed under the optical microscope. From the optical microscope pictures of alumina balls, wear volume and wear rate of alumina were calculated (table 4). Optical microscope pictures of the wear tracks on the PCD surfaces and their corresponding worn out alumina balls (inset) are shown adjacent to each other for each experiments in figure 4a–p. Under each condition, two set of loads were applied, corresponding to wear tracks of the inner and outer radii, which thereby are for lower and higher loads, respectively.

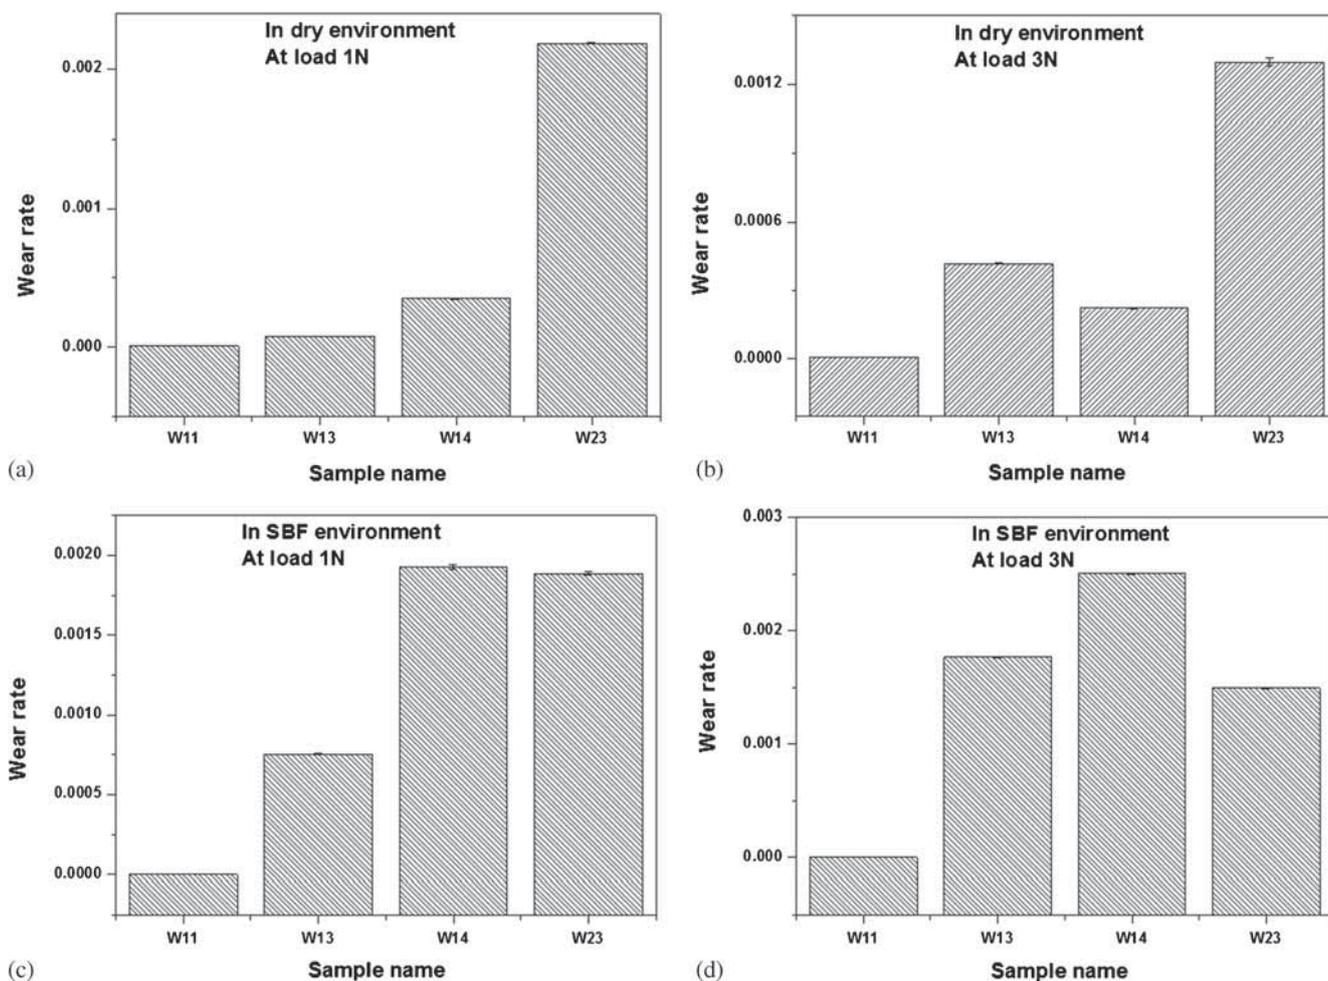
Figure 5. Wear rate of W11, W13, W14 and W23 (a) at 3N and (b) 1N load in dry environment and (c) at 3N and (d) 1N load in SBF environment.

Figure 5 is a description of alumina ball's wear rate with variation of the PCD discs in the different experimental environment. The PCD coatings are different from each other in respect of their roughness and quality. It is to be noted that as we move from the as-grown PCD to chemo-mechanically polished PCD, the surface becomes smoother. Nucleation side of the deposited diamonds is the smoothest. On the other hand regarding their quality, the diamond samples can be

It is observed that for all the respective values, W11 has the lowest wear rate data, which may be due to its very low surface roughness. Such low value of surface roughness is because it is the nucleation side of the PCD coating. In the presence of lubricant (SBF), W14 has the highest wear rate, which may be due to its less thickness, giving rise to base substrate effect [47]. On the other hand in the dry environment, it is observed that W23 has the highest wear rate data. W23 has the highest roughness among all the samples, which is responsible for the highest wear volume generation at the dry environment. Therefore, it may be that the SBF is responsible for reversing the trend in wear rate generation for W14 and W23, i.e., the highest wear data. W23 has higher

roughness and better Q -factor than W13, so its wear rate was always higher except under SBF at 3N load. The exception can be explained as follows: the wear debris generated faster for W23 than W13 to fill its asperities and, as a result COF value decreases to generate less wear rate for W23 than W13.

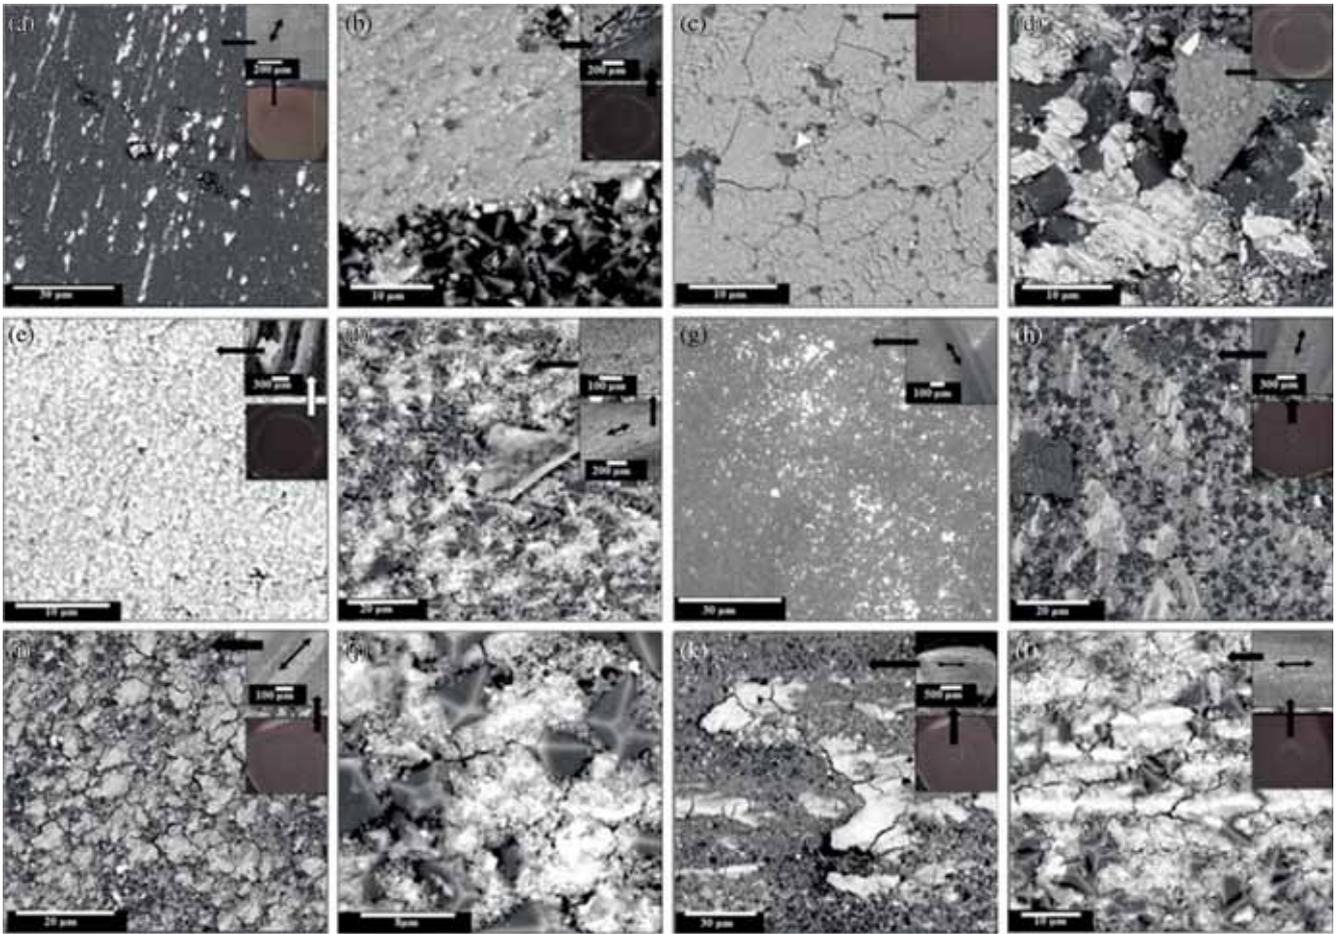
Figure 6. SEM images of wear track with different magnification (a) W11, (b), W13, (c) W14 and (d) W23 at 3N load and (e) W13, (f) W23 at 1N load under dry environment; (g) W11, (h) W13, (i) W14, (j) W23 at 3N load and (k) W14, (l) W23 at 1N load under SBF environment.

3.2c Wear observed under SEM: Wear morphology of the PCD surfaces are explained by SEM images in figure 6 and the inset images of PCD wear tracks at lower magnifications alongside are also shown. The direction of sliding movement was indicated by double-headed arrows in figure 6. SEM picture reveals that PCD crystals do not wear rather it gets covered with alumina wear debris. The wear debris was found to be compacted or loose, depending on the experimental environment. Diamond surface was five times harder (~ 100 GPa) than the alumina counterbody (~ 20 GPa), so from the tribology experiment we get the expected result that most of the alumina ball was worn out and in few cases only some cracks (figure 6a–l) on the diamond-coated surface were observed under SBF condition, which at higher magnifications was found to be the dried out alumina wear debris. Figure 6a shows the SEM image of sample W11. At the lowest

magnification level (show in the inset image of figure 6a), clear circular wear mark is visible. Such lowest magnifications have been provided in most of the SEM images of figure 6, to understand better the circular wear tracks that were developed during the present series of tribological experiments. A portion of such circular wear tracks was further magnified in each case to observe a section of it, which again is shown in the inset of figure 6. Further magnification of such sectional wear arcs reveals detailed microstructure of the wear regions, as depicted in enlarged figure 6. Such successive higher magnified images are shown by arrows in figure 6. SEM picture of W11 sample (inset figure 6a) shows some white wear debris on the outer radius (3N load) of the sample, and at higher magnification some white patches along with black spots are also observed. There was no significant wear debris found on the wear track of the hard nucleation side of the PCD coatings. Some black spots were shown on the surface, which may be due to amorphous carbon, sp^2 carbon impurities (figure 6a). W13 sample shows full surface coverage with white wear debris on the outer wear tracks at higher magnification in dry condition and adjacent to the white wear debris blackish PCD crystals were

found (figure 6b). It was clearly observed that PCD surface does not wear at all with the presence of perfectly shaped diamond polyhedrals and the adjacent white patch may be due to alumina ball (will be confirmed from EDX). W14 sample shows complete white wear debris coverage on the outer wear track at higher magnification, and very few black spots were visible which are due to protruding diamond crystals (figure 6c). The SEM picture at higher magnification of the outer track of W23 sample clearly shows that the wear debris fills the valleys, and the PCD polyhedrals remain unaffected during sliding action of alumina balls (figure 6d).

SEM images of W13 sample on inner radius (1N load) also show wear debris on the tracks and increasing the magnification at a particular area shows complete coverage of PCD surface with white wear debris and the diamond polyhedrals were not visible (figure 6e). Inner wear track of W23 sample (figure 6f) shows similar surface morphology like the outer track of W23 in a dry environment (figure 6d).

SEM image of W11 sample in SBF condition shows that wear debris were washed out from the wear track and were got accumulated on the wear track periphery (figure 6g). W13 and W23 are as-grown samples and their rough surface contains many crystal asperities. The SEM images of W13 and

W23 samples, at both the applied loads in SBF, show similar surface characteristics, where whitish alumina wear debris fills the low valley areas in between surface asperities and the PCD crystals are protruding out from here and there (figure 6h, j and l). Some cracks are observed inside the wear debris filled areas and from the SEM images it was clearly found that the cracks were not across the diamond crystals. These cracks may be generated due to drying out of wear debris which formed paste under SBF condition. W14 sample was deposited for 7 h, so its PCD crystal sizes were small, and it was also chemo-mechanically polished, so that the high troughs were flattened out. Their SEM images show many cracks on the dried out wear debris with diamond polycrystals scattered around in wear debris matrix (figure 6i and k).

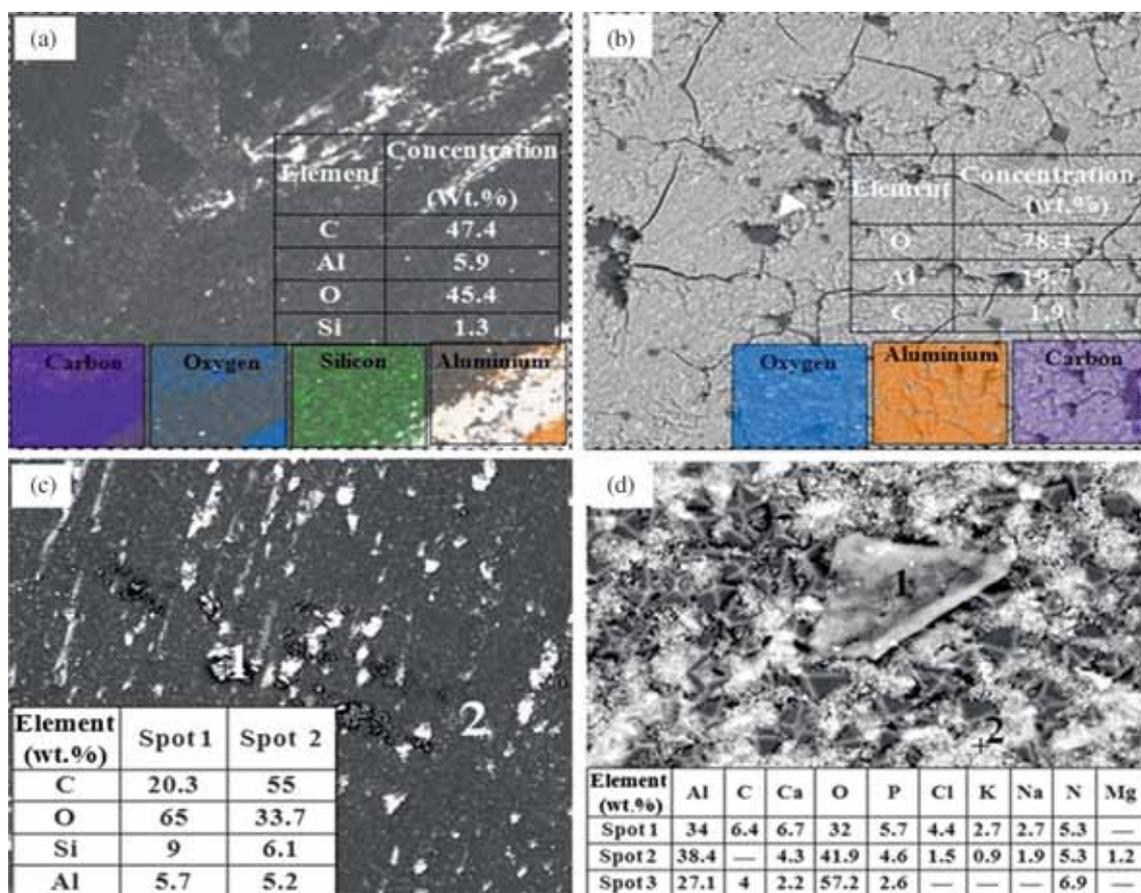
Figure 7. EDAX area scans of (a) W14 (beside wear track) and (b) W14 (inside wear track); point scans of (c) W11 and (d) W23 inside wear track.

3.2d Elements present on the wear tracks—EDX analysis: Elemental analysis of the wear tracks on the surfaces of different microwave plasma enhanced chemical vapour deposited samples were studied to understand better the chemical nature of the whitish layers and the black polyhedrals visible under SEM. Figure 7a and b, respectively, represents the area elemental EDX beside and inside the wear

track at the dry environment for W14. The point EDX at dry and SBF environment was shown for the samples W11 and W23 in the figure 7c and d, respectively. Wear track/marking was generated due to the friction of alumina ball with the hard diamond surface. The higher amount of debris was found with increasing roughness of the diamond sample. The quality of each PCD coating ensured that there is enough sp^3 phase present for the coating not to wear out, rather it caused the softer alumina counter-body to wear severely. EDX study of figure 7a proves the wear of alumina ball, as the elemental analysis of wear debris shows a certain amount of aluminium, which comes from the ball only. However, most of the element present was carbon in the PCD surface region of figure 7a. W14 sample had highest COF value though its roughness was lower than other two as-grown samples due to Si substrate effect. The area elemental analysis of the W14 PCD coating adjacent to the wear track shows 1.3 weight percentage of silicon (figure 7a). It might have come from Si substrate, because the deposition time of W14 sample was 7 h only, so the coating thickness was very low. In figure 7b, white patches were seen on the wear track of W14 sample and the area EDX analysis shows higher weight percentages of aluminium and oxygen present, than carbon. Therefore, from the EDX analysis, it was confirmed that white wear particles were generated from alumina counter face. The

surface roughness was lowest for the nucleation side of W11, but its COF value was high and comparable with the as-grown sample W13. From the point EDX analysis of W11 nucleation side it was evident that both the spots contain little weight percentage of silicon (figure 7c), as the base substrate was silicon and this silicon might be in carbide form. High COF value of W11 can be attributed due to the presence of silicon on the smooth nucleation side. In both the spots of figure 7c, aluminium was found, so it is again evident that the alumina ball was mainly worn out. Figure 7d denotes the SEM image of the wear track of W23 in SBF condition and its point EDX analysis at two different points. EDX data show the presence of different elements which came from the SBF solution. Spots 1 and 3 in figure 7d show little amount of carbon, which comes from the diamond surface. Spot 2 shows no carbon as this area was full of white alumina wear debris.
